Restoring a monster

Many collectors keep a lookout for radios from the interesting period around 1930 — when most receivers used simple tuned radio frequency (TRF) amplification, and had evolved into impressive devices built like battleships. This month we look at typical project involved in bringing one of these beasts to life.

Many of the pre-1931 receivers surviving today are American built TRF types and the chassis from one of these, the 1930 Columbia AC-9-30, is the subject of this month's 'adventure'. As can be seen from Fig.1, it is very massive — weighing about 20 kilos — and has an equally substantial early Jensen speaker to match.

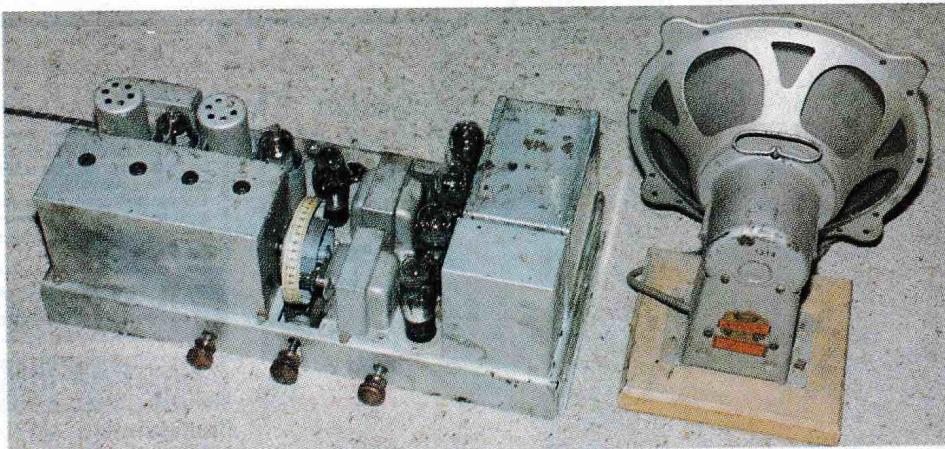
As can be seen from the photograph, the chassis is quite long, with the four RF stages and detector in a row along the centre line. In front of these is the shielded four-gang tuning capacitor. Running transversely are the audio and rectifier valves, while at one end are the rectangular boxes containing the power transformer and filter capacitors.

Fig.1: By the year 1930, receivers like this Columbia TRF had grown to massive proportions.

Frequently too (and there was evidence of this in the Columbia), they would fit the nearest available but inappropriate replacement component. One example can be seen left of centre in Fig.1, where a large 25 watt resistor of the wrong value has been used to replace a 5-watt section of the voltage divider (mounted on the right hand rear of the chassis).

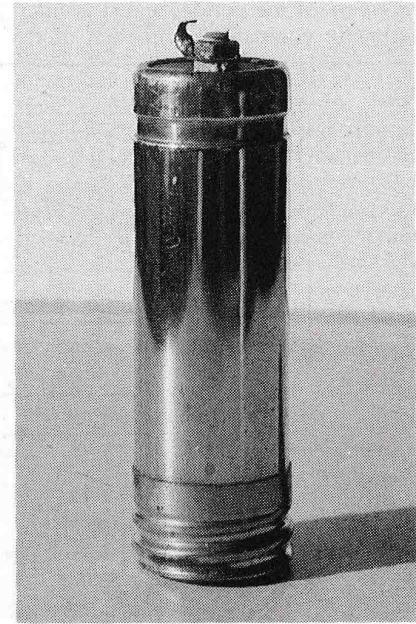
Fig.4: An interesting link in the evolution of the traditional wet electrolytic capacitor, this copper cased example was hidden inside the box alongside the power transformer. Note the threaded socket for easy changing in the event of failure.

The filter capacitor box was unbolted, and found to contain not a tightly packed group of paper filter capacitors (which it was obviously originally designed for), but instead three unusual copper-cased electrolytic capacitors, one of which is shown in Fig.4. 1930 was a period of rapid advances, and probably what had happened was that the development work on the chassis had been based on using paper filter capacitors, but by the time that production was under way, the cheaper and higher capacitance Mershon electrolytics had become available.

These copper cased capacitors proved to be an interesting evolutionary type. They are the same size as the standard aluminium cased wet type that were to be found in many chassis made during the 1930's, but they are mounted in a threaded brass socket, with the terminal at the top end. No doubt the elaborate mounting was to facilitate replacement in the event of failure — a likely possibility with the new and relatively unproven type of capacitor.
