Vintage Radio

The Vintage Serviceman...

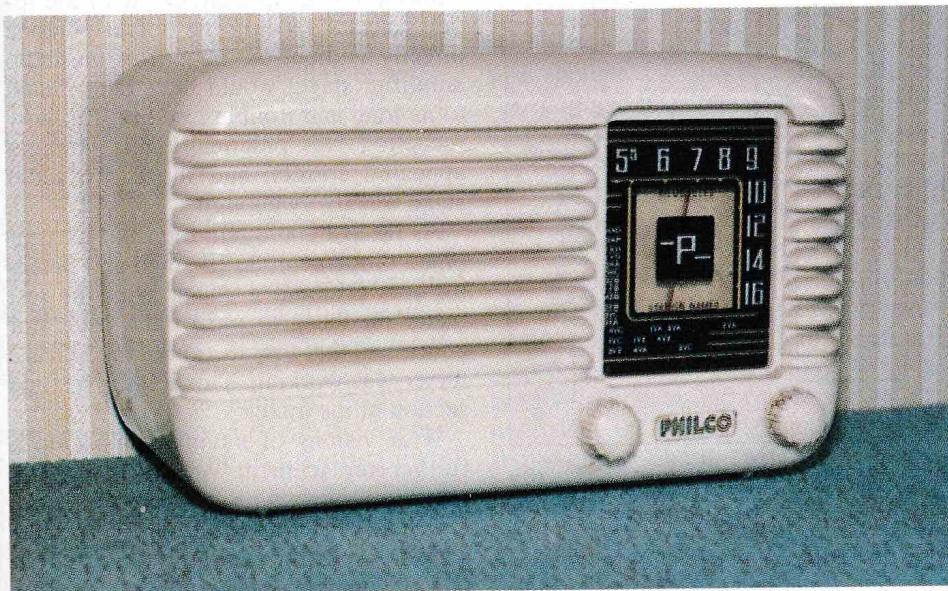
Fig.1: With only three Philips Noval valves plus rectifier, this little New Zealand made Philco receiver has a very basic circuit not unlike the 'Little General'. After 40 years of trouble-free service it developed a classic fault...

The final holiday 'surprise' was the small plastic-cased and New Zealand made Philco receiver shown in Fig.1. This had given 40 years of faithful service and I was assured that previously, it had never been serviced. The complaint was that it was 'very weak'.

This particular receiver is of the 'Little General' type, but with automatic gain control. The simple circuit, with the diode detector feeding the output pentode directly without the benefit of an audio amplifier stage, would have contributed to its long and trouble free life. But now reception was practically nil. Voltages appeared correct, and the EL41 audio stage was lively enough.

touched the coil end of this lead. There was no response! Taking care not to disturb anything, a check with test meter confirmed that there was no continuity between the coil and grid whatsoever!

Was the wire broken inside its insulation? A good tug on the lead showed the answer. It came away cleanly from the coil, without a trace of solder! A classic dry joint, it had taken all this time to reveal itself.

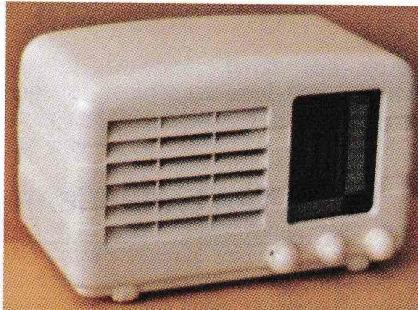
Fig.2: The Bell 'Colt', which provided some headaches out of all proportion to its modern size and circuit. Colts surely hold the World's record for longevity as a production model. First produced in 1951, it was made during the following 20 years, and continued as a transistorised set until 1980! Australian readers may recognise the cabinet as having been used for the Airzone 458 of 1946.

But the world does not stop for holidays, and when I finally arrived home, waiting for me was a Bell 'Colt', a little box of tricks that was to take far longer to fix than it should have and bring me back to earth with a jolt. A laconic note taped to the cabinet simply said 'NO GO'.

have changed value. Sure enough, the 150k anode load resistor for the audio stage measured more than two megohms. This was soon replaced and while I was about it, I tested the valves which all checked out as being quite healthy. With the power turned back on I confidently sat back, waiting for a response.

It was then I noticed something that I had previously missed. The wax that seals the IF transformer tuning slugs had been disturbed. Each of the four cores had been attacked and damaged, apparently with a steel screwdriver. The correct tool for these particular cores is a hexagonal plastic alignment tool.

Two of the slugs were still serviceable when reversed, but I had to replace one transformer whose former had been cracked. It is not uncommon to find that screwdriver adjusted trimmers have been screwed up tight, but to remove wax seals to get at ferrite slugs requires quite a lot of determination...

With the transformers repaired and replaced, IF realignment was straightforward, and there was some reception; but the stations were in the wrong places. By now I was prepared for anything, and sure enough, I found that the oscillator coil slug had been tweaked. Fortunately, the padder in these sets is fixed, eliminating one variable. Even so, it took quite a while to get the oscillator tracking correctly, especially as the tuning capacitor trimmers had also been 'adjusted'!

That was the problem. A replacement aerial coil restored performance to normal. It would seem that somehow, somewhere, possibly in the factory, the wrong type of coil had been installed. Who knows, maybe the damage to the receiver was the result of attempts to remedy the poor performance. I never did find out.

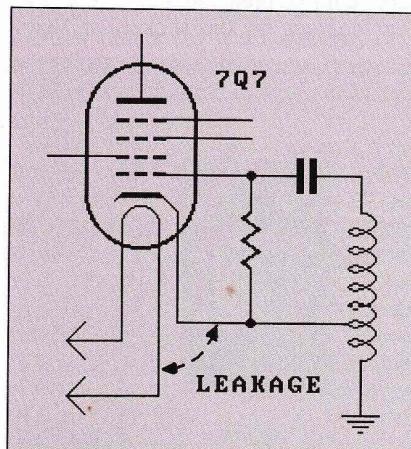
This simplified diagram of the oscillator section of the Courier receiver illustrates how heater to cathode leakage could create severe hum by modulating the RF oscillations via the coil tap. Had the cathode been directly earthed the leakage could well have gone unnoticed.

This receiver has a heptode 7Q7 converter valve, an uncommon type that is in fact electrically identical to the more familiar 6SA7 and similar to the miniature 6BE6. As these valves have no oscillator anode, the cathode would not necessarily be directly earthed, but connected to a tap on the oscillator coil. It seemed likely that this was the way the leakage hum could be modulating the oscillator signal.

There was not much more I could do but to identify the 7Q7, so that it could be swapped for a good one that I would send when I returned home. I do not like having to leave 'cures' for intermittent faults unproven. Too often the brilliant 'diagnosis' turns out to be wrong, but it seems from subsequent reports that in this case we were lucky.

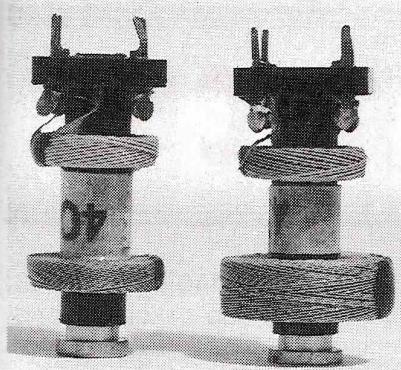
Fig.3: Matched aerial and RF amplifier coils. The upper tuned windings are of course identical, but the relative difference in size between the two lower untuned windings is clearly visible. The aerial coil is on the left. Swapping the two can seriously affect the performance of a receiver.

To simplify tracking with random external aerials, and to equalise gain over the tuning range, it has been common practice to fit both aerial and RF amplifier broadcast band coils with primary windings which are resonant at a frequency a little below 500kHz. However, as aerials provide additional capacitance, aerial coil primaries have a lower inductance than their companion RF coils. The difference can be clearly seen in Fig.4. Could it be that this receiver had the wrong type of coil? Surely not — but with this particular set, anything was becoming possible.
