GOLDEN KNIGHT model BTR 48466

## AN INTERESTING PROJECT

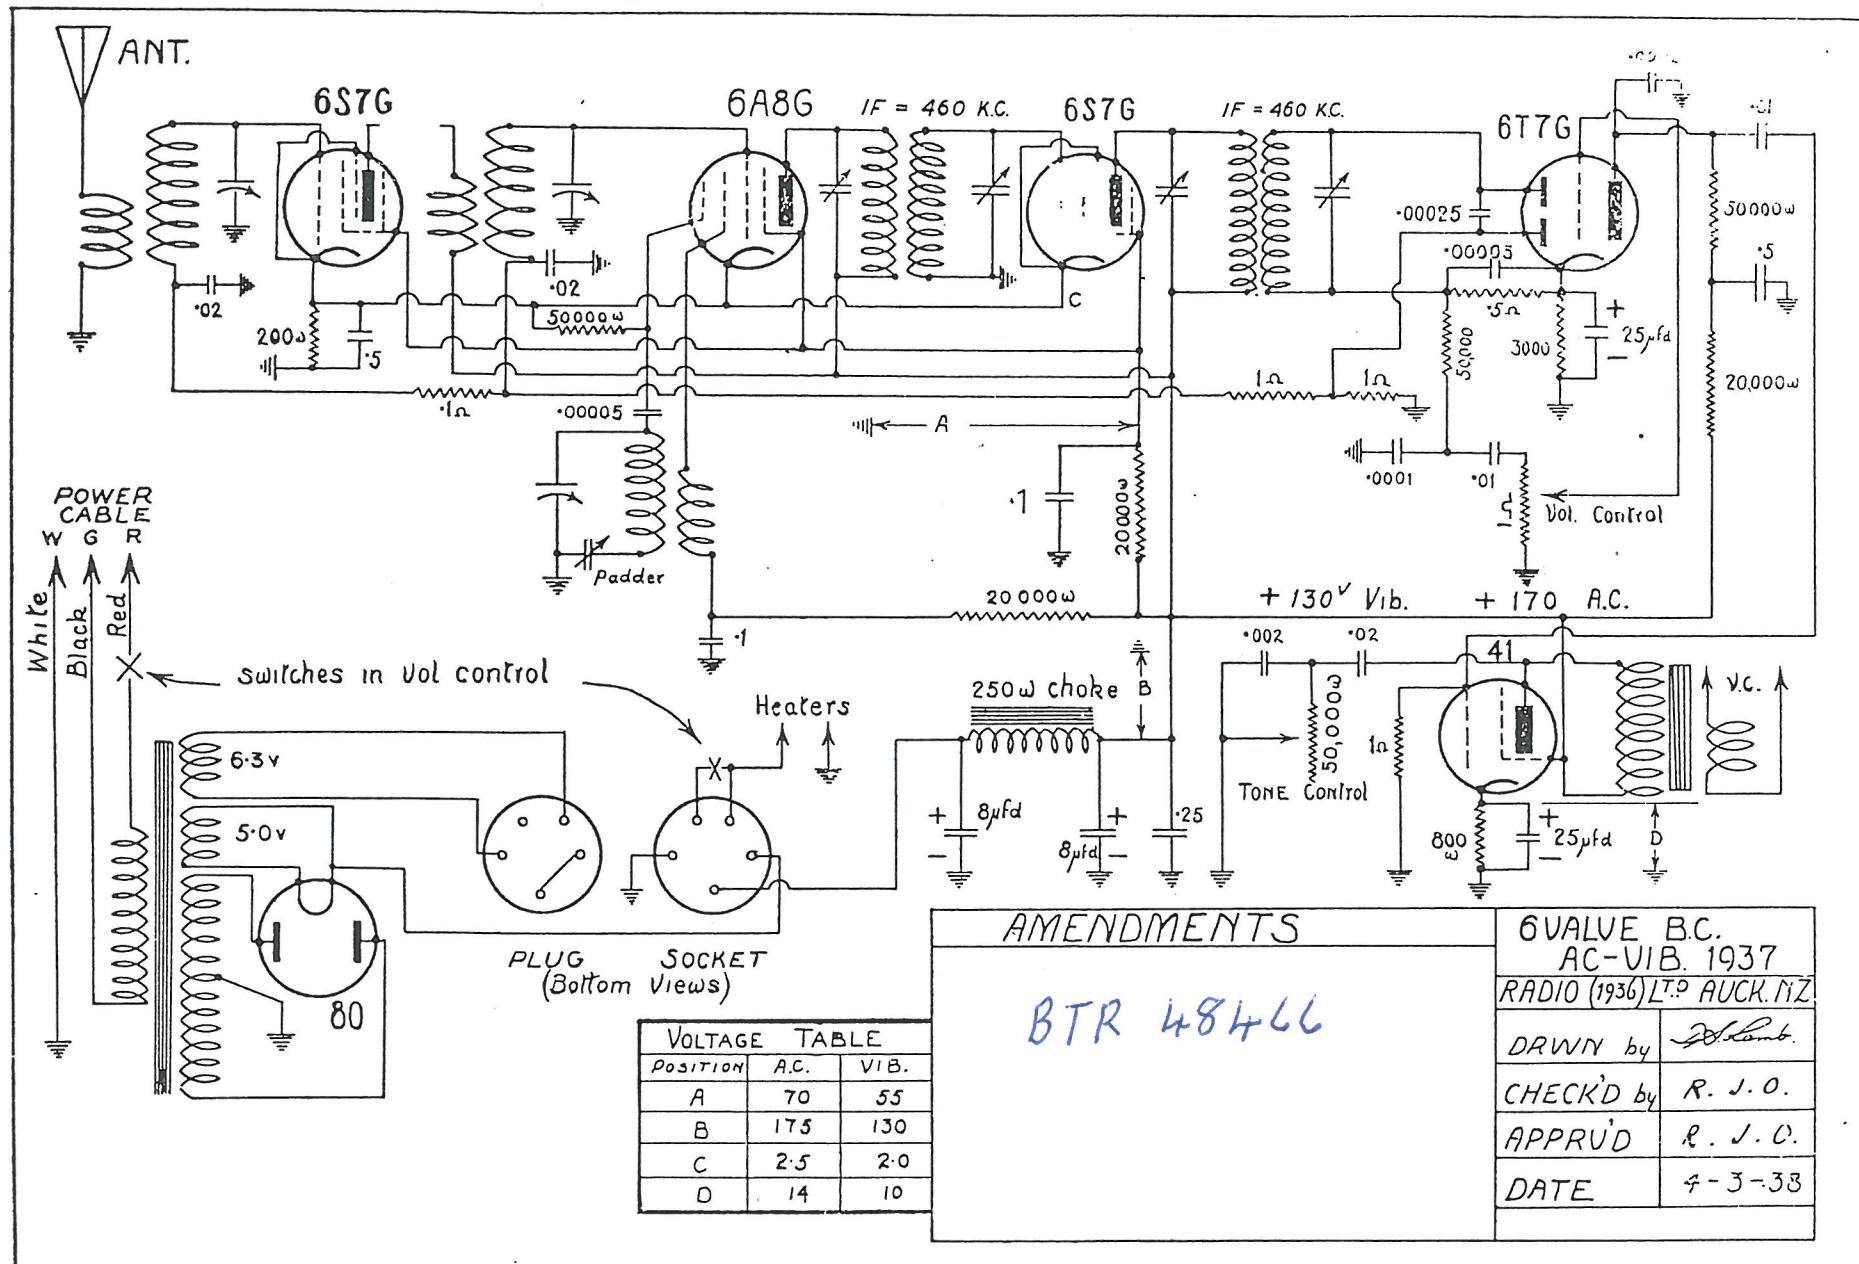
6 BC 48466  
1937

The radio turned out to be a handsome tombstone, broadcast only, model BTR 48466 circa 1937. (Radio Limited manufacture). The valve line up, according to the valve sockets, was 6S7G, 6K8G, 6S7G, 6T7G, 41 and 80 rectifier. As can be seen in the photo there is an extra power cord running from the transformer to a socket on the back of the chassis marked 'vib' This would allow a battery/vibrator power supply to be simply plugged in.

There wasn't that much wrong with the radio. I replaced both power cords - the old rubber insulation was hard and brittle. I took the old electrolytic capacitors out of circuit and fitted replacements underneath the chassis. I changed a couple of original wax coated paper capacitors. Previous work on the set had already replaced most of the original paper capacitors.
