NEW ZEALAND VINTAGE RADIO SOCIETY INC.

Vol. 21 No.4

February 2001

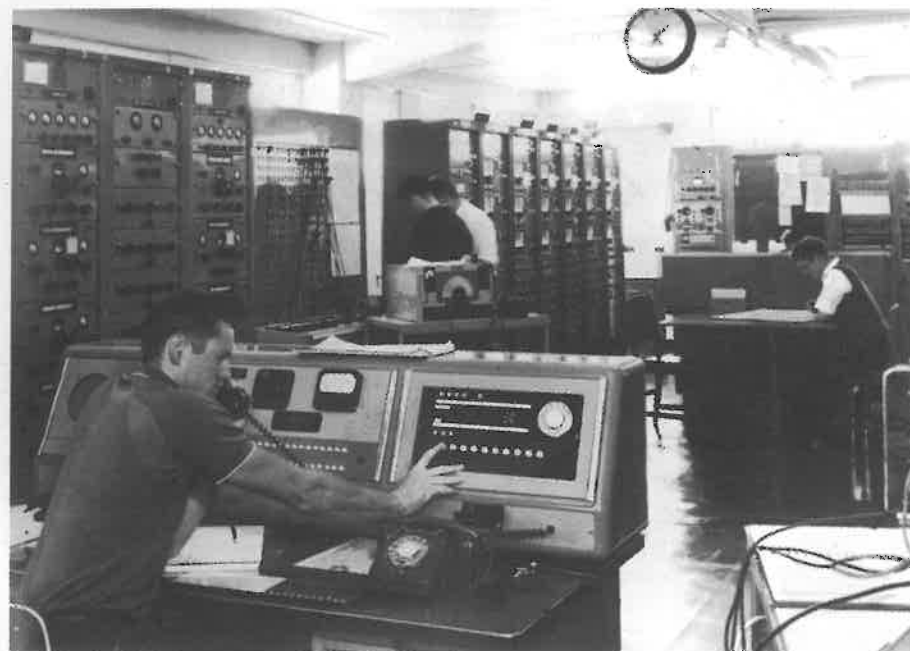
NEW ZEALAND POST OFFICE HIGH FREQUENCY
RECEIVING STATION ESTABLISHED AT MAKARA IN 1944

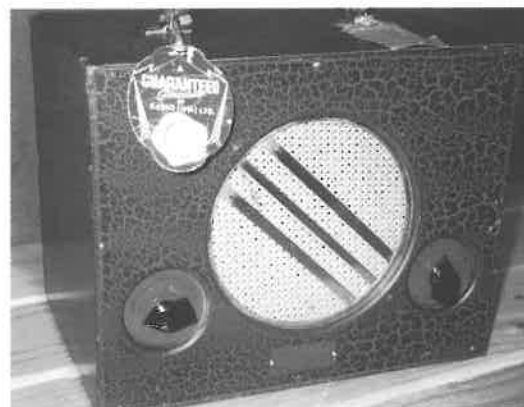
ULTIMATE MODEL CMU (1938)

What we found inside the cabinet was a chassis that was in pristine condition with all the original components on board just as it would have left the factory some time during 1938. The weight problem was simple - the set was designed to run from a 6-volt battery and had the necessary vibrator supply built in.

Work Needed - Replace aerial, earth and battery wires that have been cut off. Replace paper caps. Check out the vibrator supply and then trust that all works.

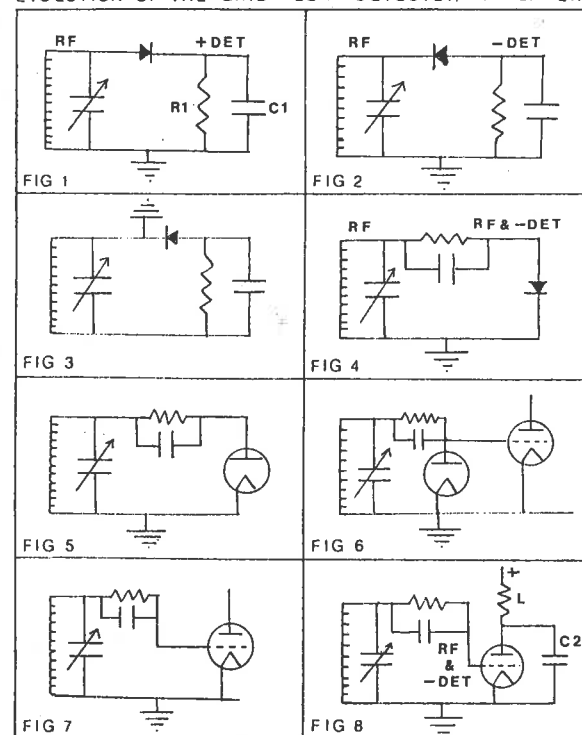
Taking the -DET circuit of FIG. 2, we move the earth to a different position, see FIG. 3, and simply re-draw the circuit, FIG. 4. Now the voltage with respect to the earth or ground connection (measured across the diode) is a combination of the RF carrier and the detected voltage across the resistor and capacitor. This is represented graphically in FIG. 12. Using a good silicon diode and efficient detection, the positive tips of the RF carrier get "clamped" a diode voltage drop above ground. Tube diodes are resistive and the "clamping" is less effective and the carrier peaks rise up above the reference level when the carrier amplitude is higher, to some level, as indicated by the dotted line on FIG. 12. The detection is less efficient on account of this, and the demodulated signal amplitude

Moving on to FIG. 5, the semiconductor diode has been replaced by a tube diode, and in FIG. 6 an amplifier has been added. The amplifier's grid/cathode behaves as a diode, so we can remove the original diode, see FIG. 7, and the circuit function is the same, assuming of course that the grid/cathode is as efficient as the original tube diode, which for practical purposes is reasonable, however the effective diode function is moderately resistive. In circuits FIG. 4 through 8, the resistor can be returned to the opposite side of the tuned circuit, with minimal effect except that the capacitor's discharge pathway includes the RF coil.

As is usual the best place to start is at the beginning, with the simplest detector circuit, see FIG.1. This arrangement is the familiar half wave circuit. Positive peaks of the RF carrier voltage cause diode conduction and the capacitor, C1, is charged, discharging between the peaks via the resistor, R1. Between the positive peaks of RF carrier the diode is reverse biased. The RF voltage can be represented graphically, FIG. 9. The output from this detector tracks the envelope of the positive half cycles of the RF carrier, and the voltage developed across R1 and C1 is the recovered modulation, called +DET or positive detection.

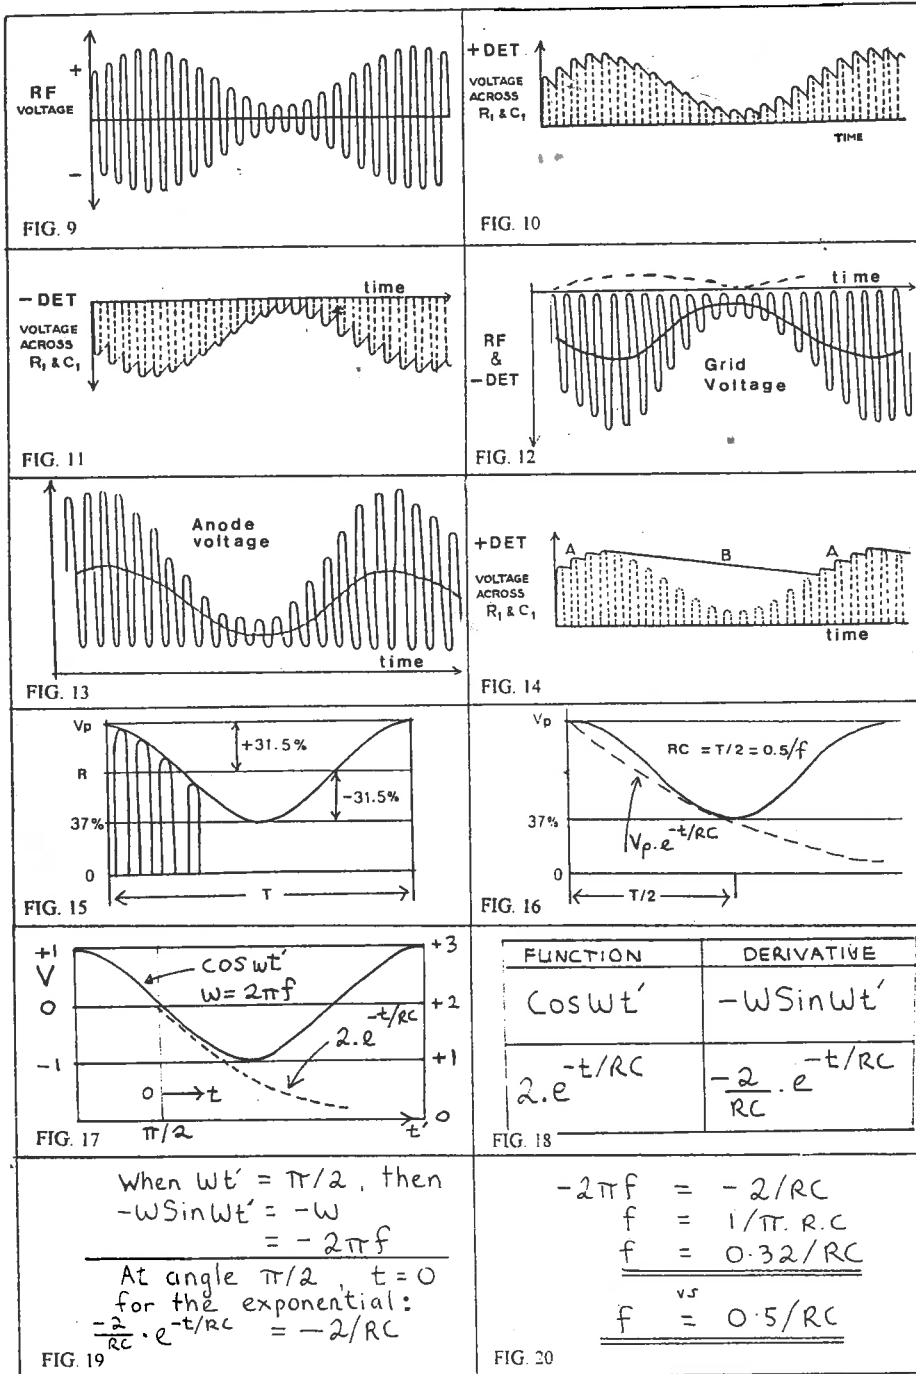
1) Fig 15 shows a hypothetical wave of audio modulation of an RF carrier, rising 31.5% above its resting level R (no modulation) to V_p and falling 31.5% below resting level. Therefore the RF carrier on its positive half cycles troughs down to 37% of V_p on account of the modulation. This value has been chosen deliberately to simplify calculations. If we look at the exponential decay of the voltage on an RC network starting from point V_p , so that it falls fast enough so it is below or equal to the trough in the modulation half a cycle later, see FIG. 16, the values are easily calculated. This is because the time taken for an exponential to decay to 37% of its starting value is the 'time constant' equal to R times C . So we can conclude that provided the RC value is equal or less than half the period of the wave, $T/2$ or put another way 0.5 divided by the frequency, f , then negative peak clipping will not occur. This relationship is then, $f = 0.5/(RC)$ where f is the maximum allowable modulating frequency. This is a very good approximation, but not entirely accurate as it slightly over estimates the allowable frequency: as can be seen the exponential is not quite rapid enough to track the faster falling part of the modulating wave

2) FIG. 17 shows a better way, a cosine wave of modulation, rising and falling one volt above and below its resting value, which is 2 volts above zero. This could be described as 50% modulation. The rate of change with time of this modulating wave at its most rapid part, one quarter of its way into the cycle, an angle of $\pi/2$ radians, can easily be found by taking the derivative of the cosine function and finding the value at that point. The functions and their derivatives are in the table, FIG. 18. Likewise if we consider an exponential starting to fall from the same point (quarter of the way into the modulating cycle) from its timing $t = 0$, toward zero, which is two volts away, we have the exponential function shown in FIG. 17 as the dotted line. We can easily calculate the rate of change of this function by the derivative, see table FIG. 18 again, and determine the value at $t=0$ for this exponential. See FIG. 19 where these two rates of change are calculated. If we make them equal, then the exponential decay of the grid leak capacitor charge via the grid leak resistor is just "fast" enough to track the modulation. This is done in FIG. 20 and the value we get is $f = 0.32/(RC)$.

3) A third way to calculate this is from information provided by Terman about AM detection, pg 555. That provided that the AC impedance (to modulating frequencies) divided by the DC impedance of the detector load is greater or equal to the modulation, m , and that this rule is not violated, then distortion (some form of negative peak clipping;) is avoided. " m " is defined as the crest of the modulating wave rising above the no modulation level, divided by the no modulation RF level. For the wave illustrated in FIG. 17 then $m = 1/2$ or 0.5. This gives an even more conservative result. It can be calculated from $R.X/(R.(\text{square root of } (X^2 + R^2)))$ equals m . This is the AC impedance of R and C in parallel, divided by the DC impedance R , where X is the reactance of C . If we make this equal to 0.5 (50% modulation), from this I calculate the formula to be $f = 0.275/(RC)$. This clearly ensures that the time constant is fast (short) enough to track the modulation without ever ending up with the situation illustrated in

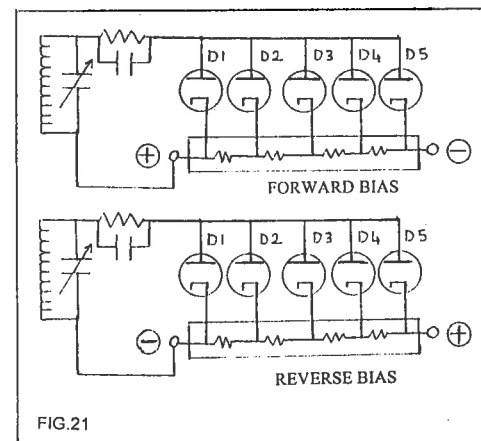
FIG. 21

The practical reality of a directly heated tube diode (or triode used as a diode) throws in some interesting features. We can model this as a group of diodes (or grid/cathodes of triodes) and a voltage divider representing the tube's heater element. The heater element (filament) has a voltage distribution. See FIG. 21. When the RF circuit (and grid DC return) is to the positive side of the heater, then diode D1 has no forward bias, D2 a little and D5 has a good forward bias equal to the heater voltage. Forward bias is helpful. "The higher the plate potential, the less is the tendency

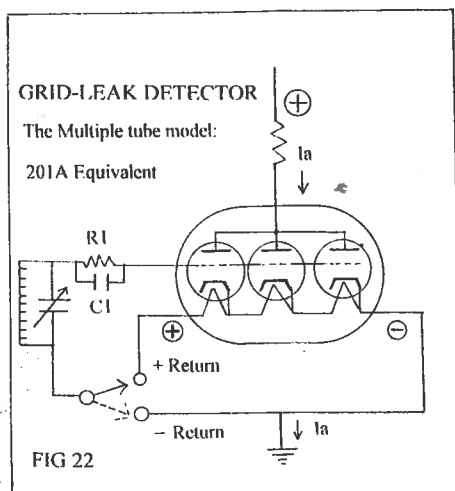
We can now incorporate a model of a directly heated triode, like a 201A. This could be composed of multiple indirectly heated tubes with their cathodes distributed along a heater chain. Three tubes are shown for convenience, FIG. 22, however we could imagine larger numbers. It now becomes clear that the choice of the grid leak return has two fundamental effects. Firstly it configures the grid/cathode or "diode" component of our triode for generalised forward or reverse bias, and secondly it changes the triodes operating point via the average grid bias. This shifts the transfer function of the tube (change in grid voltage vs change in anode current) to a different part of the triode's curve. The placement

of the ground, or earth connection, either to plus or minus filament, is academic, as the anode current, I_a , is very small with respect to the low resistance of the heater element in the tube. So you can ground either the plus or minus side of the heater in this example with no other effect.
