# **NZVRS BULLETIN**

Vol 25 No. 4

Nov. 2004

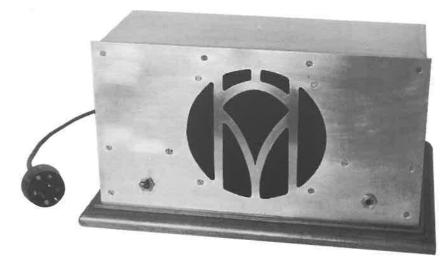
Front View of the Receiver unit

The receiver is constructed in two sections: the RF/detector and a separate power supply/amplifier unit as shown,

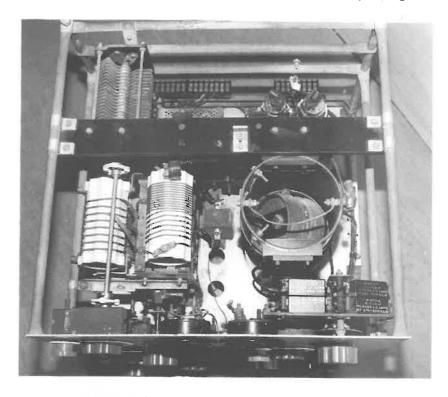
**Upper RF chassis.** On the left are the switched HF tuning coils and the HF coupling variable capacitor, On the right are the MF switched coupling capacitors and the MF tuning variometer. To the rear of the variometer are the three 807s in the power amplifier stage
