NZVRS BULLETIN

Vol 26 No. 4

November 2005

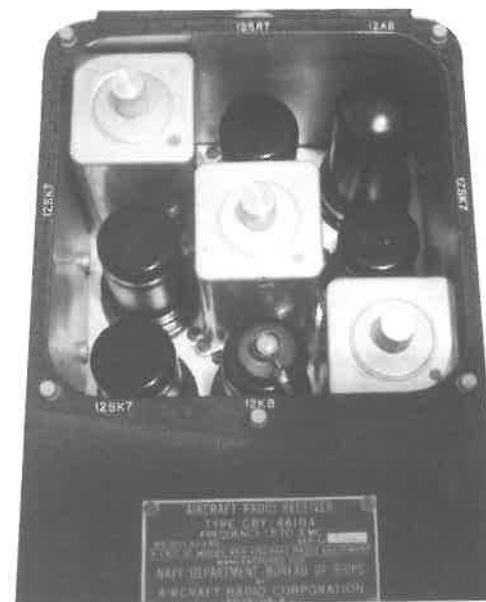
Top view of the 1.5 to 3.0mc receiver.

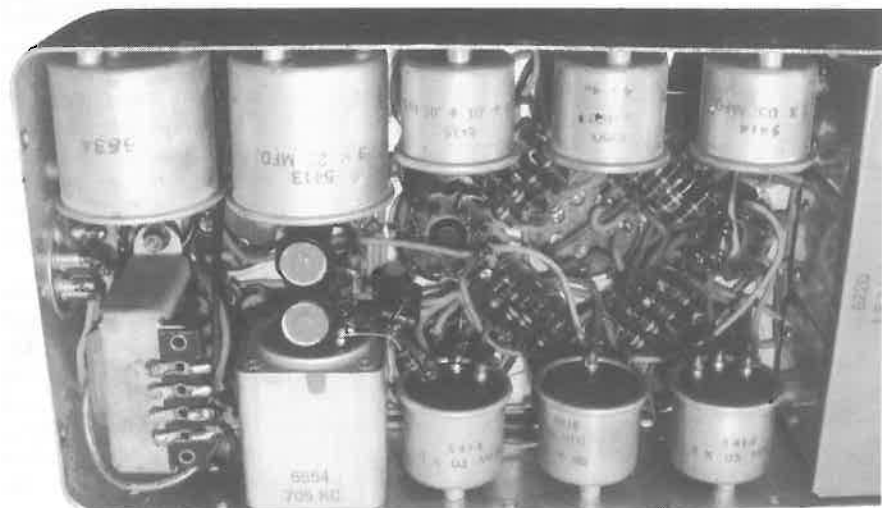
Underside of the 'ham' modified receiver.

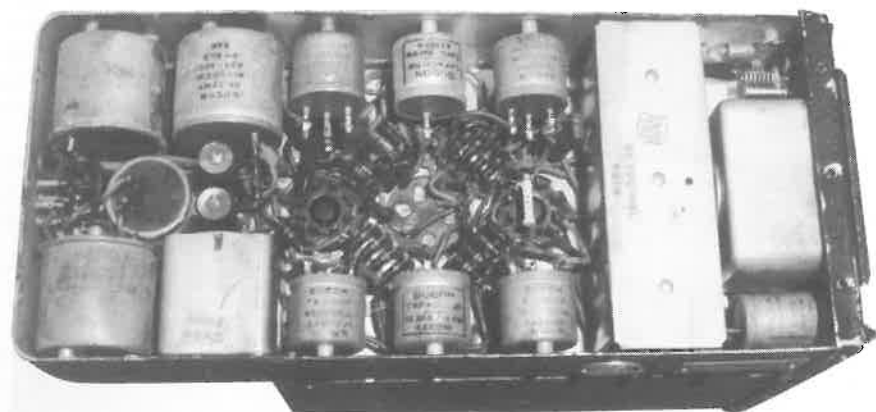
Under-chassis view of the 180 to 550 kc receiver which seems all totally original, apart from the replaced capacitors.

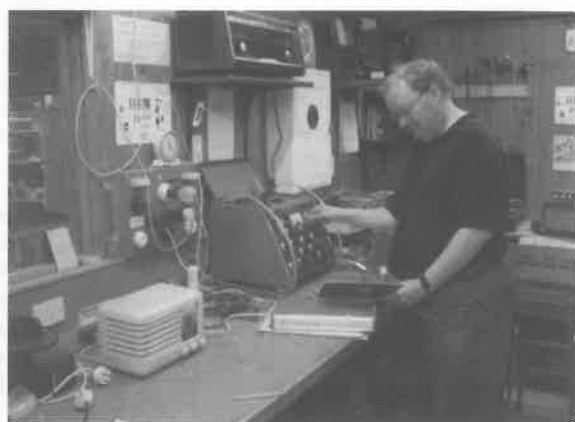
Recently arrived Californian, Mark Atherton, currently in charge of the valve department checks out an emission with his Avo Valve Tester.

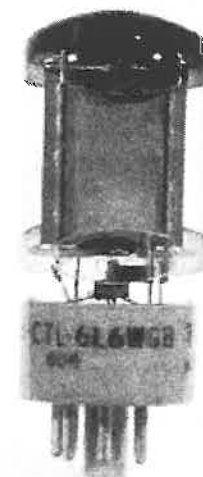
Later glass 6L6WGB

Section through a 6L6 valve, with beam-forming electrodes.

This new design was called the "Kinkless Tetrode" but was thought by EMI to be too difficult at the time to mass-produce. As there was a cross-agreement of patents with RCA the idea was rather unwisely licensed to them. And was soon to appear as the immensely successful 6L6. This valve, after 70 years, continues to be made in Russia (2 factories), China (2 factories) and in Slovakia and Serbia. Very recently a firm in the USA has bought up the obsolete valve-making machinery which would otherwise have been scrapped and the 6L6 will be
