NZVRS BULLETIN

Vol 31 No 2

May 2010

The 'Ham Can' or Philips 930A

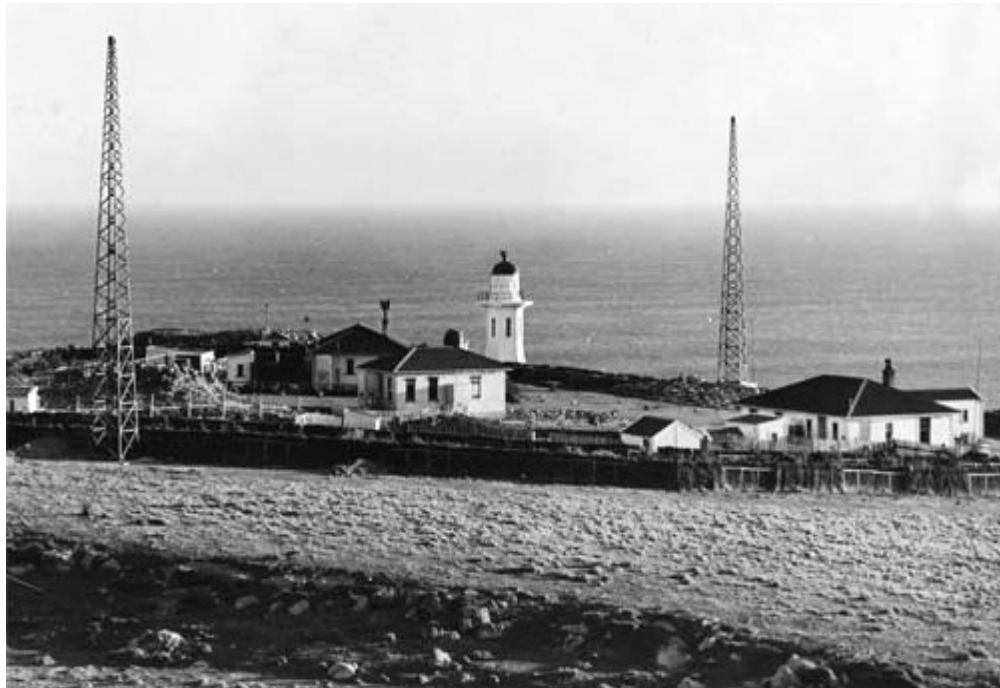
ATL Picture

Constructing a lighthouse involved more than building the tower. Keepers' houses and farm buildings also had to be built. This 1937 photograph of the Baring Head complex shows its numerous buildings and the two radio beacons that helped guide ships through Cook Strait and the entrance to Wellington Harbour.

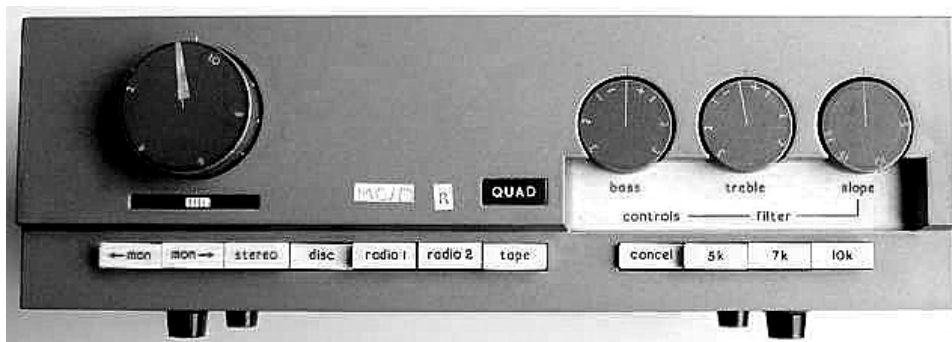
A few weeks ago I was asked by two owners if I could repair their Quad 33 preamps which drive the 303 power amplifiers. These units were made between 1968 and 1981. Both preamps were dead in one channel and what was curious was that with the stereo button pressed, the resistance of one section of the ganged volume control was 50 K ohms as expected but the dead channel appeared to have an earth fault on the top end of the volume control, not a dead short but a resistance of about 80 ohms which effectively shorted any audio signal to ground. The obvious first test was to disconnect the volume control and it tested correctly at 50 K which meant that the fault was in the wiring between the tape amplifier board and the output amplifier board. According to the circuit the only wiring is that of the left channel, right channel and stereo buttons which operate isostat switches. To all intents and purposes it looked like a fault in the isostat switch contacts. The service data does include a section on dismantling these switches so that a switch problem may have been suspected by service personnel at Quad.

The first preamp had been given to the owner in non-working condition, and there were various jumper wires connected across the mother board, and on the small circuit board above the switch bank one track had been cut and wires had been resoldered to different places on the board. The earth fault appeared initially to have been a switch contact problem and the modifications had apparently been attempted to isolate a presumed faulty section of the switch bank. But the fault was still there. I did dismantle two of the isostat switches but found nothing wrong, and I recommend that these be left well alone. The contacts on the square shaft of the switch are held in place by tiny springs about 1.5 mm in diameter and 3 mm long, and the contacts can easily drop out when the shaft is removed. Replacing them requires a magnifying glass on a stand, a pair of tweezers and a suitable tablecloth. (I used a pillowcase). In accordance with Murphy's Laws one of the springs flew out when I let go of the tweezers and I felt it flick against my neck and presumed that it had fallen on the floor. The sun was shining through the window of the sunroom and it was possible that the tiny spring might have been seen on the carpet. I did not see it so I wiped a magnet over the carpet around the writing desk but still no spring. I have a small cardboard box of isostat switches but they were all different from the one used on the Quad 33. At that point I became worried and tried to think how to explain the

With the switch now isolated, an ohmmeter test showed about 80 ohms between one of the front pins of the stereo switch and the U-shaped metal bracket which is earthed. After handling the switch a few times I repeated the test and found that the earth fault on this switch had disappeared but had reappeared on one of the front pins of the Radio-2 switch. What is noticeable with this model of switch is that there is barely a millimetre of clearance between the front pins of the switches and the U-shaped metal bracket.

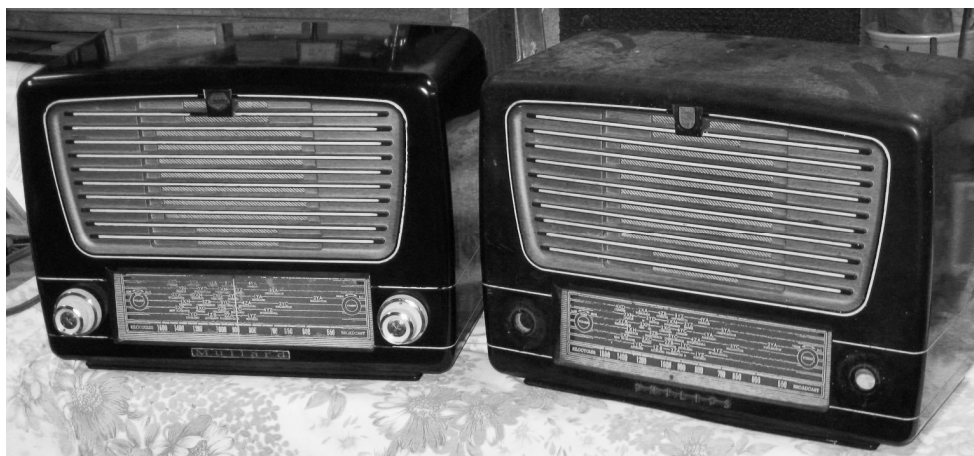
Mullard on left, Philips on right

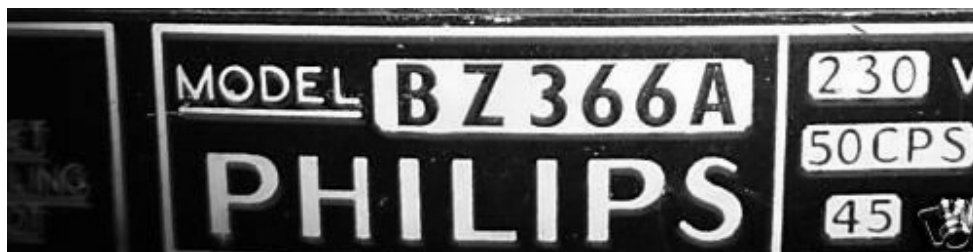
Pity the rest of the label is not included to show the “Made in NZ” detail, but in the picture of the rear of the set you can just make out the ARTS&P and NZ Philips label below the model label enlargement above.

Interestingly that the Radio Museum lists this as a Philips NZ Radio model BZ366A see http://www.radiomuseum.org/r/philnz_bz366a.html

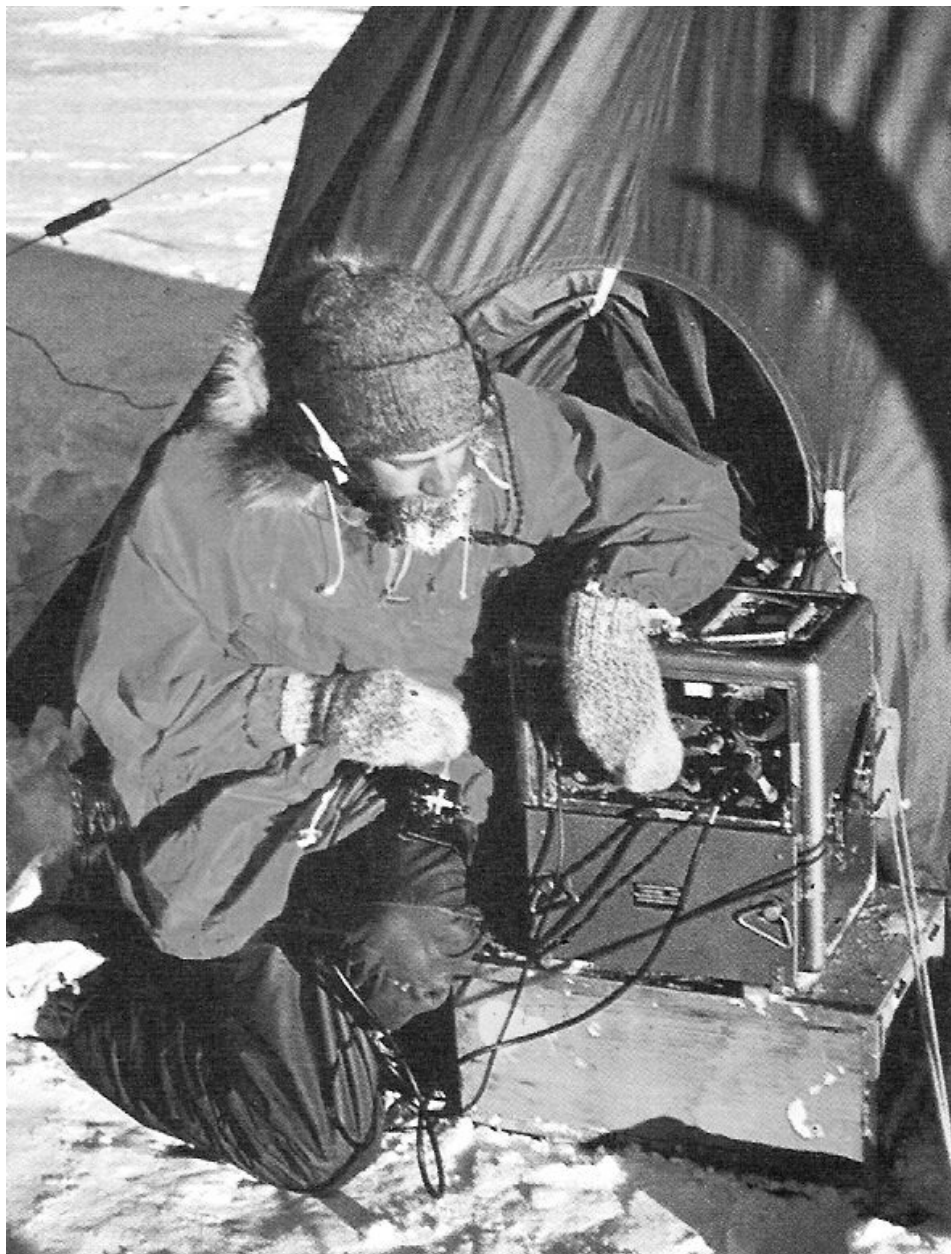
Collier and Beale's 557HF transceiver in field use c1965
(see previous bulletin for additional details)
