NZVRS BULLETIN

Vol 33 No 1

February 2012

A Restoration Tale – The Philips V7A “Theatrette”

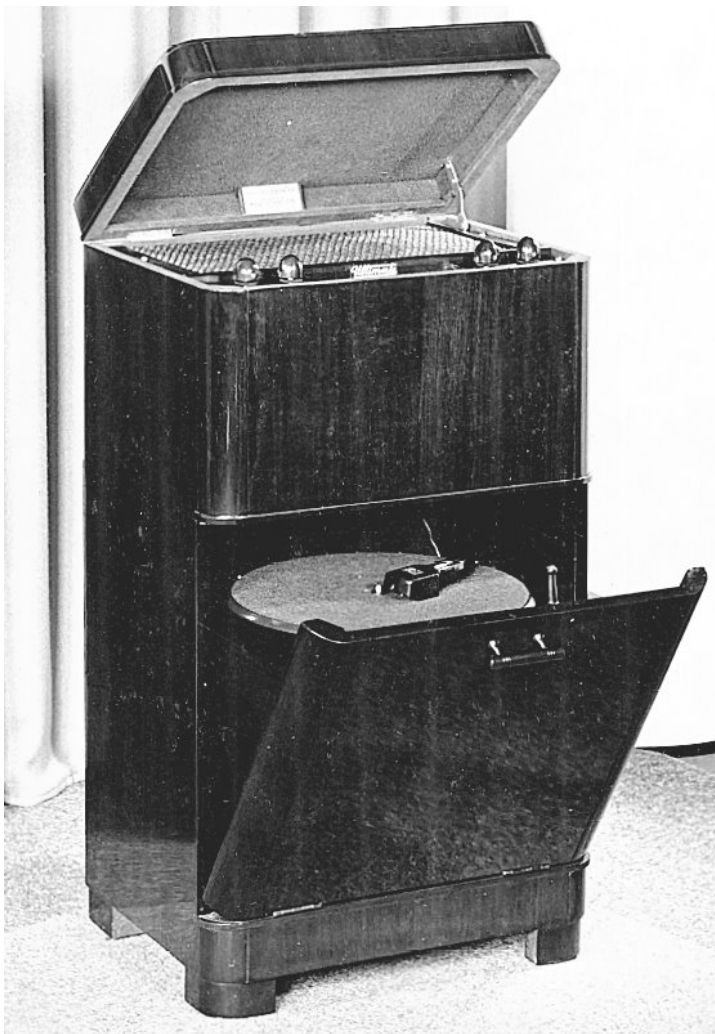
Radio (1936) Ltd 6 Valve Challen Radio Gramophone.

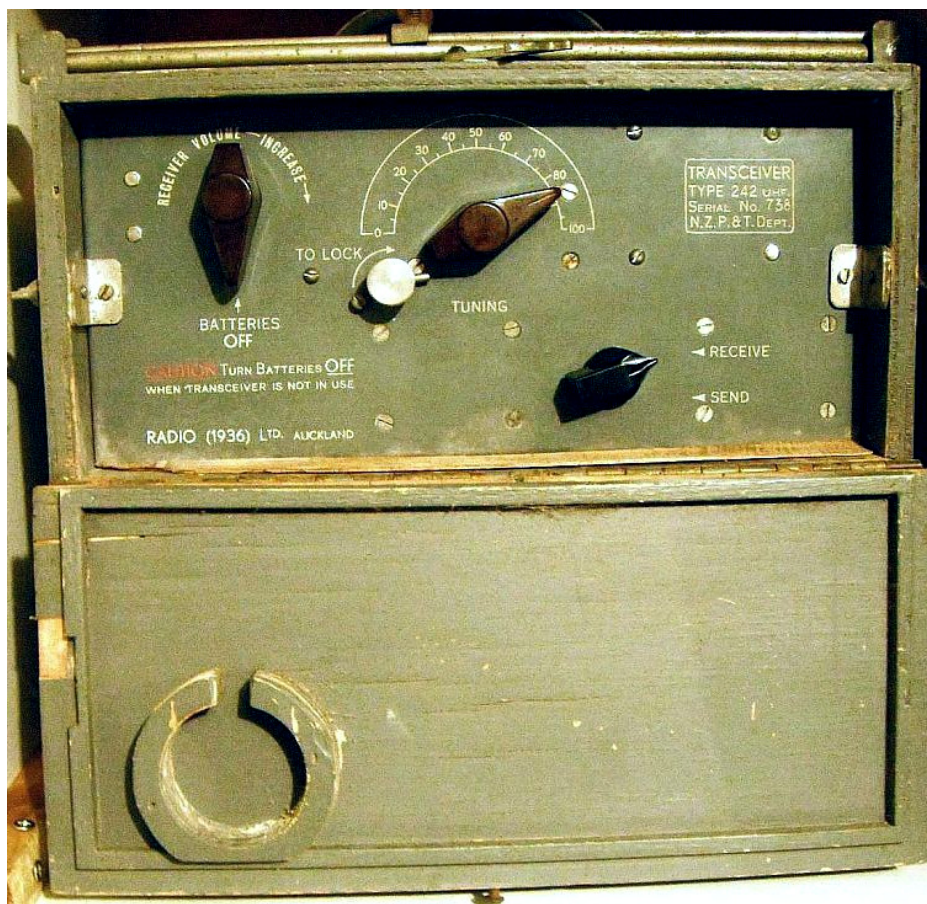
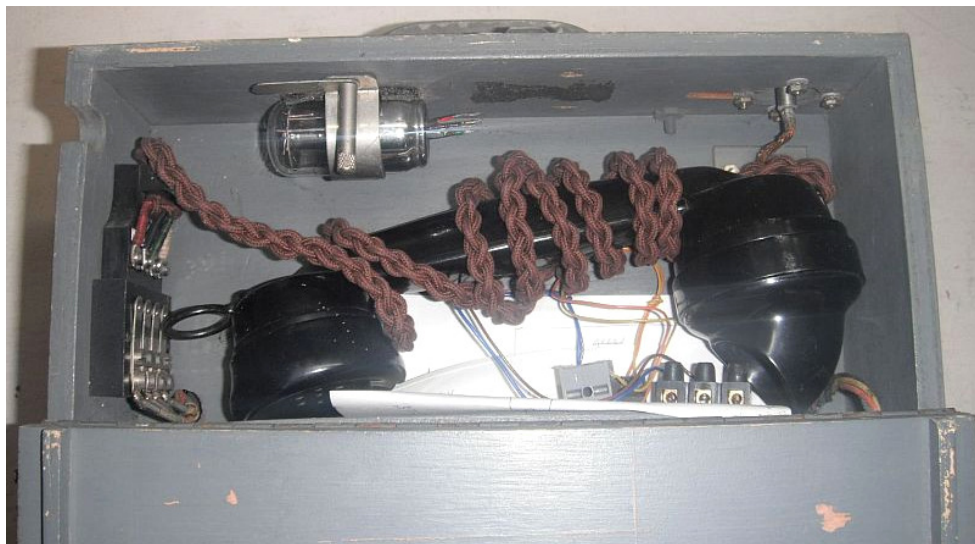
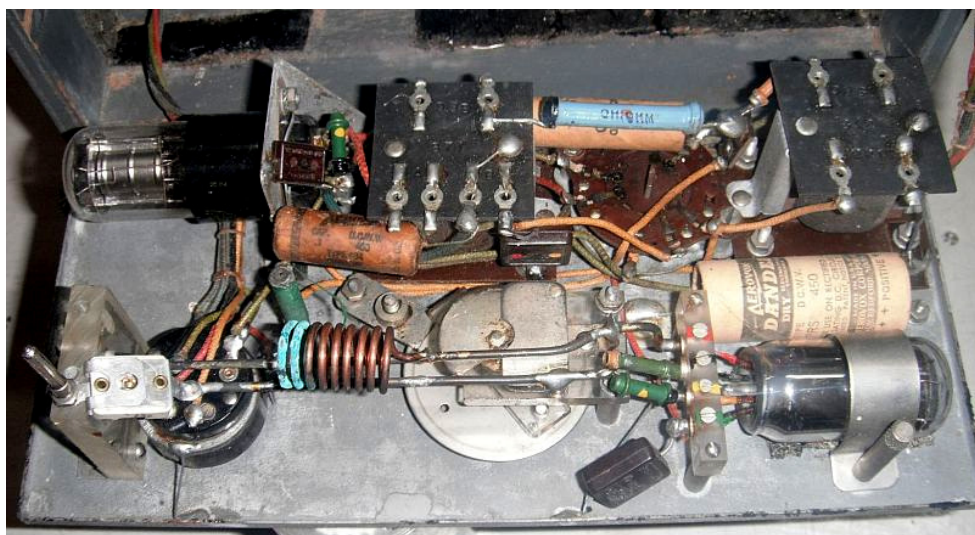
Type 242 Transceiver information wanted.

Hi, I am trying to find some information on the radio in this picture. it is a Type 242 transceiver made by Radio (1936) Ltd in Auckland. It is probably working in the low VHF frequency range. It appears to be similar in design to a British Army WS17 set. The telephone handset and spare valve is in the back of the box, and has a battery box at the bottom. The front panel has some reference to NZP&T Department so maybe they were the customer. I hope to get it going in the next few months, and find out what frequency it tries to be, but I don't expect to work much DX on it. Some interesting features I noted - the radio is held in with butterfly screws on the outside, did it have to come apart that often? The front flap has a wooden ring so it cannot be closed with the set left on. The RF valve has had its base removed - I presume to lower the pin capacitance. Could valves be bought like this? The front panel shows it to be UHF but I think they called anything over 30 MHz "UHF" in those days. The aerial rods are held in a clip on the top surface. Can any of your members give me any information on this? I would love to know when it was made, I am guessing just post war, and why it was made. Many thanks, Kelvin ZL3KB via Email: KB.EW@xtra.co.nz

I have answered Kelvin directly, I have never seen this 1942 set which was obviously ordered by radio purchasing on behalf of some Government Department such as Forestry or Civil Aviation. I would have been working on Radar at that time or away in Fiji. The circuit is quite straight forward being a Hartley oscillator possibly super regenerating on about 50 Mc/s L2 being the tank circuit with CV2 and stray capacitances. It could have been used by NZPO technicians for communication while checking Defence Department directional antennas which were located on NZPO HF radio stations at that time. I do not know any technician who is still alive.

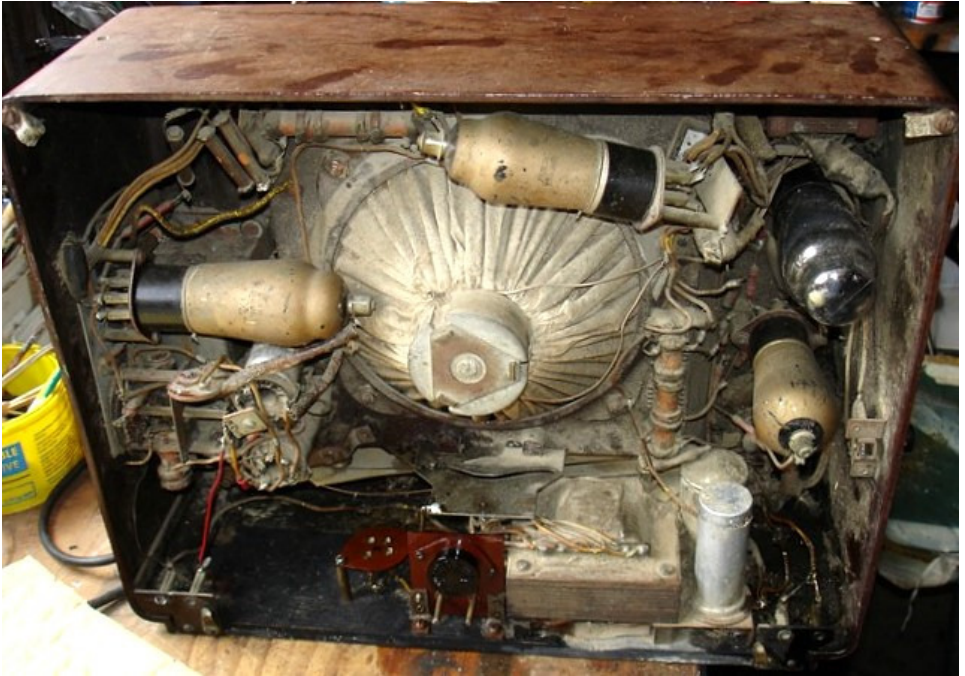
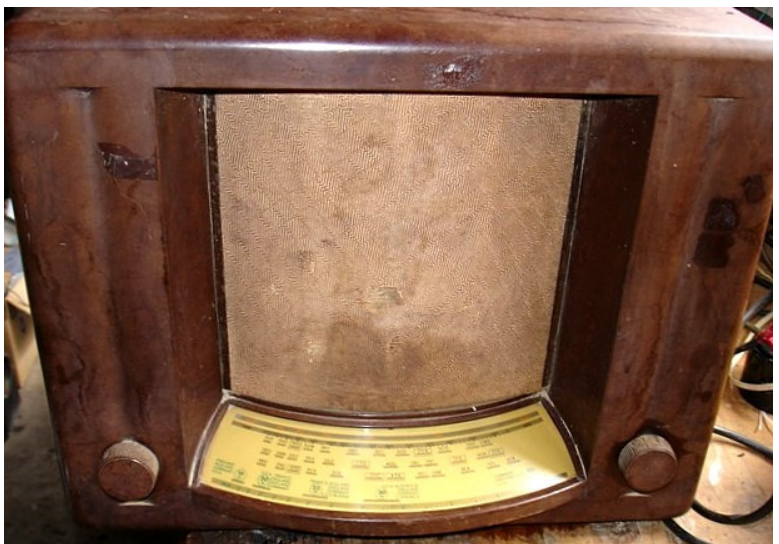
This set had always intrigued me with it's chassisless construction, with valves and components draped around the 4 sides of the case and the speaker in the middle. Also, tales of 'never again' and dire warnings from some other restorers indicated a challenge, so when an affordable set came up for bidding, I had to have a go, and became the new owner.

The story starts with the sets arrival. Unpacking breakable sets is always nailbiting, but this one had somehow survived. I knew there was no back, power cord, or rectifier valve, but I didn't know about 4 holes drilled in the top and side at each end of the rear of the case - to hang

it up perhaps? The seller claimed the set worked, but one look at the perished wiring and corroded electrolytic cans meant I wasn't going to risk trying it.

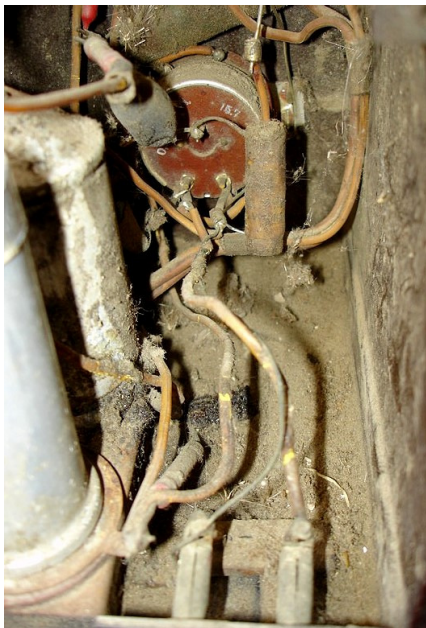
A view of some of the gunge.

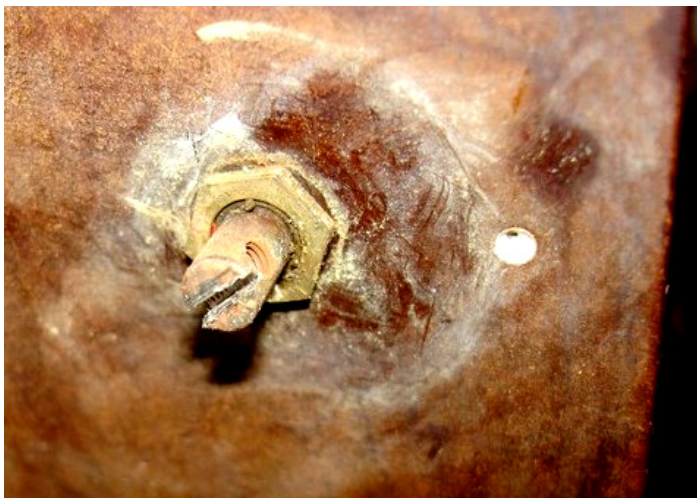
Closer examination of the internal layout suggested the possible sequence of assembly as follows: Speaker and metal grid holding the grille cloth would have been in place first. The 3 gang tuning capacitor, dial drive mechanism, output transformer added. Then the rest of the circuit including valve sockets,

perhaps pre-wired on a jig, could then be dropped into the case and a few connections made.

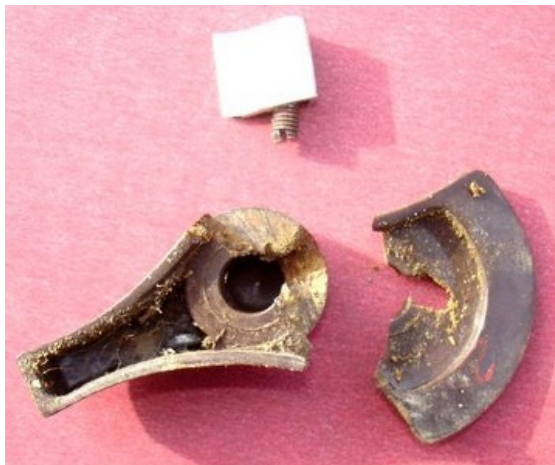
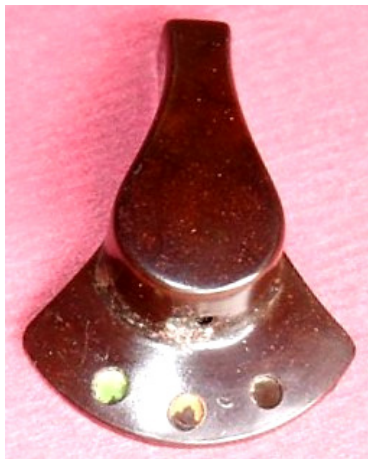
The first snag: The grub screw holding the switch knob was seized solid. Being a Philips, the screw went right through a threaded hole in the shaft. Heating the shaft inside the set, adding kerosene etc failed to loosen it, also half the screw had broken off on one side of the slot. (All the other knobs came off easily – *a well documented Murphy Law. Ed.*) Butchery was called for. The knob was finally hacksawed free and a slot cut in the end of the shaft, parallel to the screw and just reaching it. A screwdriver prised it open enough to free the screw.

The knob was epoxied back together and any gaps filled with a mix of superglue and Bakelite dust. Note: this works quite well to repair Bakelite, but the mix sets hard almost immediately, so dripping in the glue then sprinkling the powder is usually necessary. [*or try using superglue gel. Ed.*] A new screw was made from a longer one of the same thread.

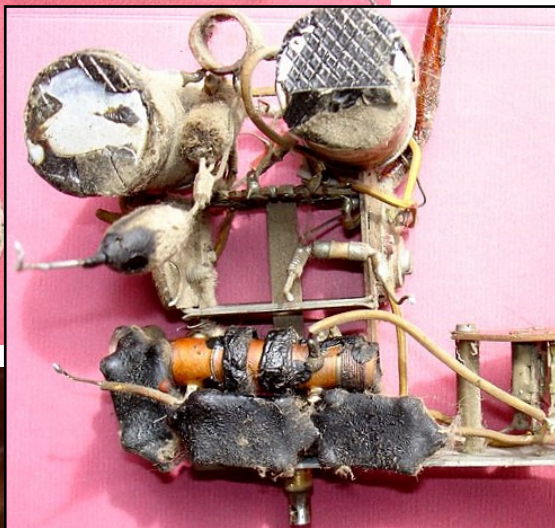
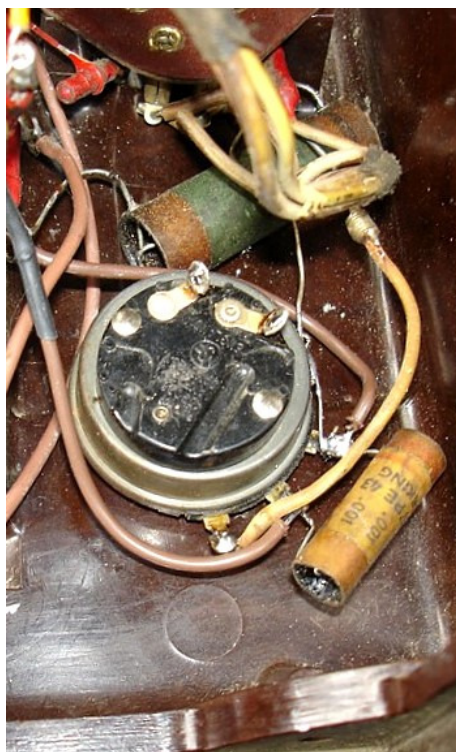
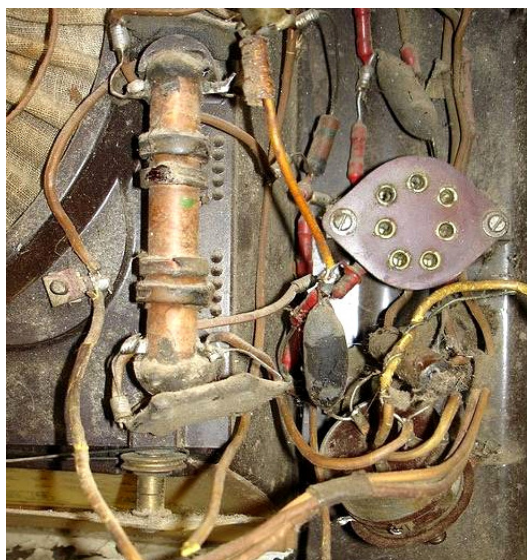
Left: Replacement volume control and restuffed capacitor shells.

**Above: IF stage original
Very Top: Wave change assembly**

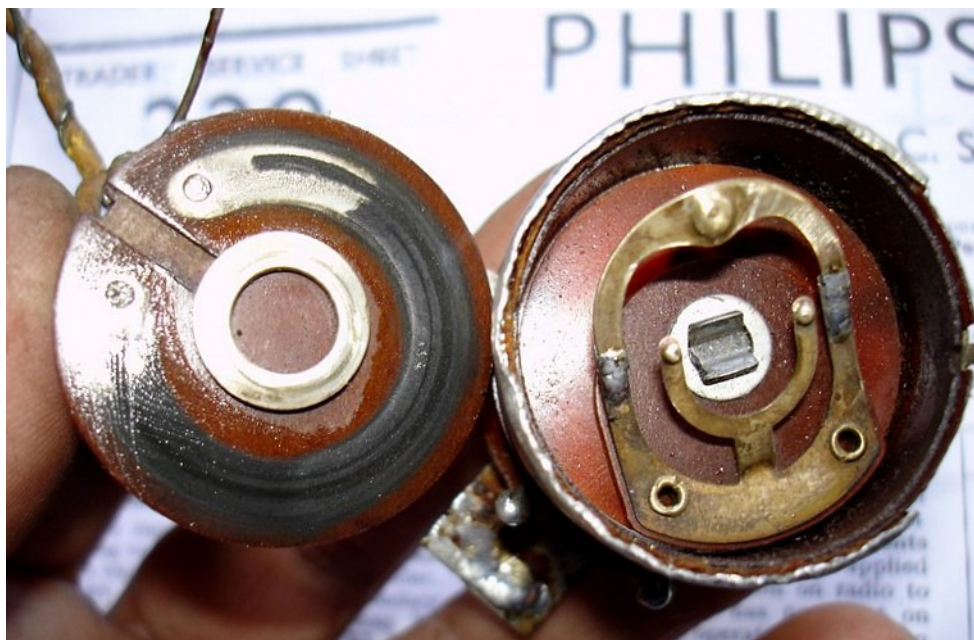
But it wasn't going to be that easy. The volume pot didn't work until about one third rotation, and touching any component or wire around the Ant./RF assembly gave a crackle and loss of signal. The pot was removed, and dismantled. Most of the first part of the track had worn off but by cutting and resoldering the moving arm, an unworn part of the track was swept.

Alas, the rivet connecting the track to its terminal was loose and had damaged the track. Fortunately, I had a vintage pot that would do the job and it was swapped in.

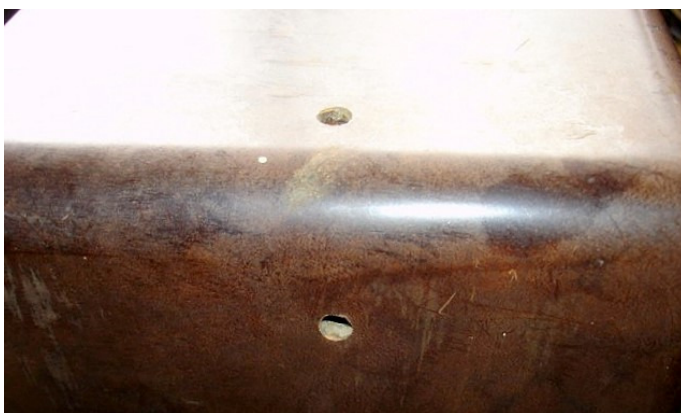
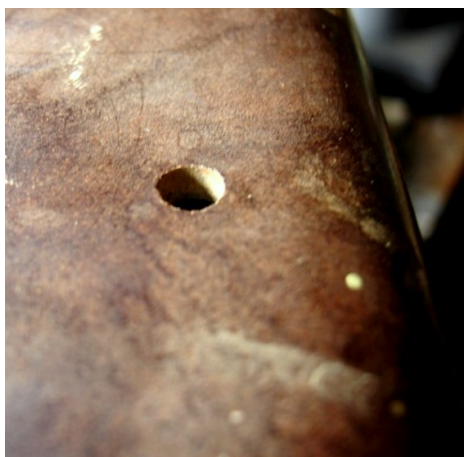
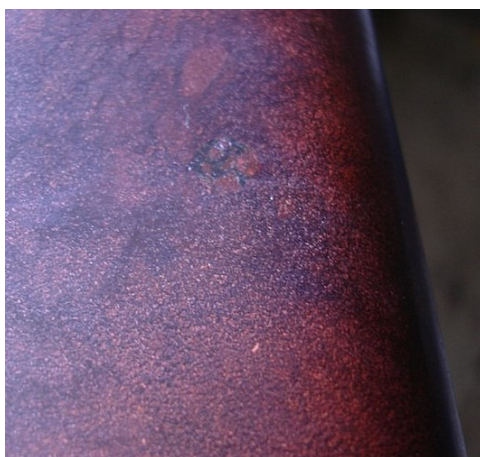
Cabinet holes before and after.

Note: Once the original shiny Bakelite surface has gone, the fillers (if used) are more obvious and the surface seems 'hungry' for wax. Applying this over several days before final polishing usually works well.

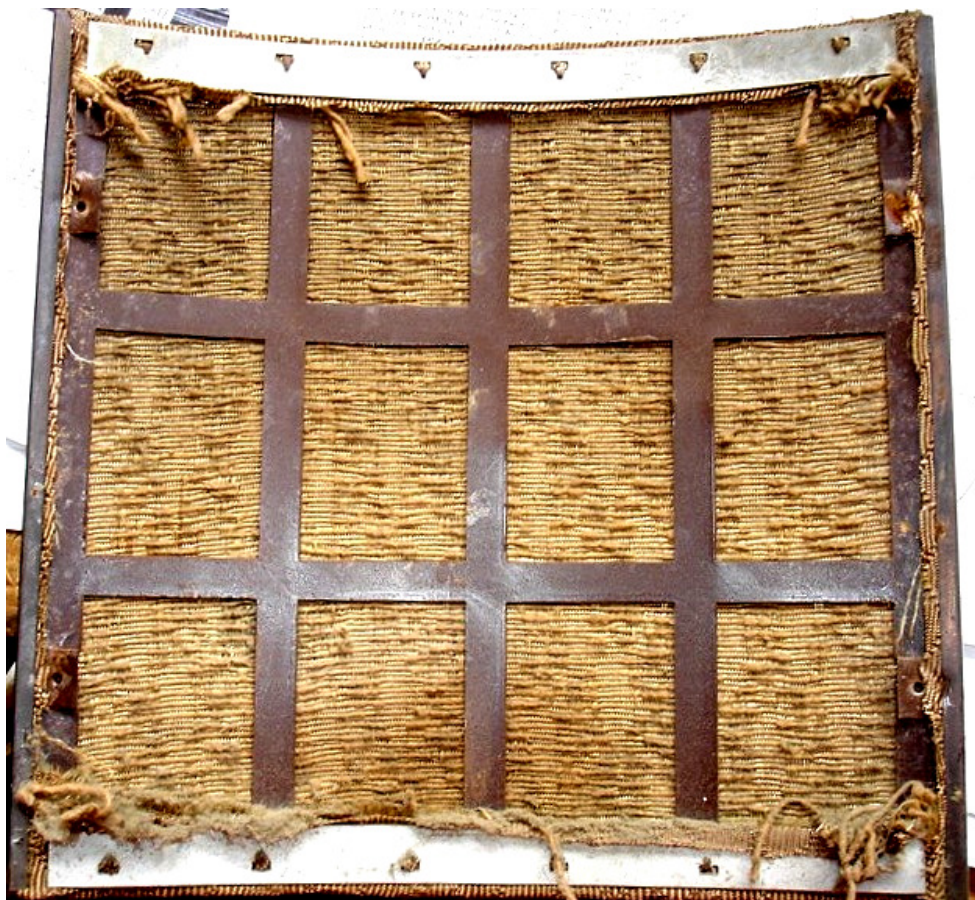
Although the radio is attractive from the front, the startling appearance from the back is unique.

The layout looks more like evolution than design.

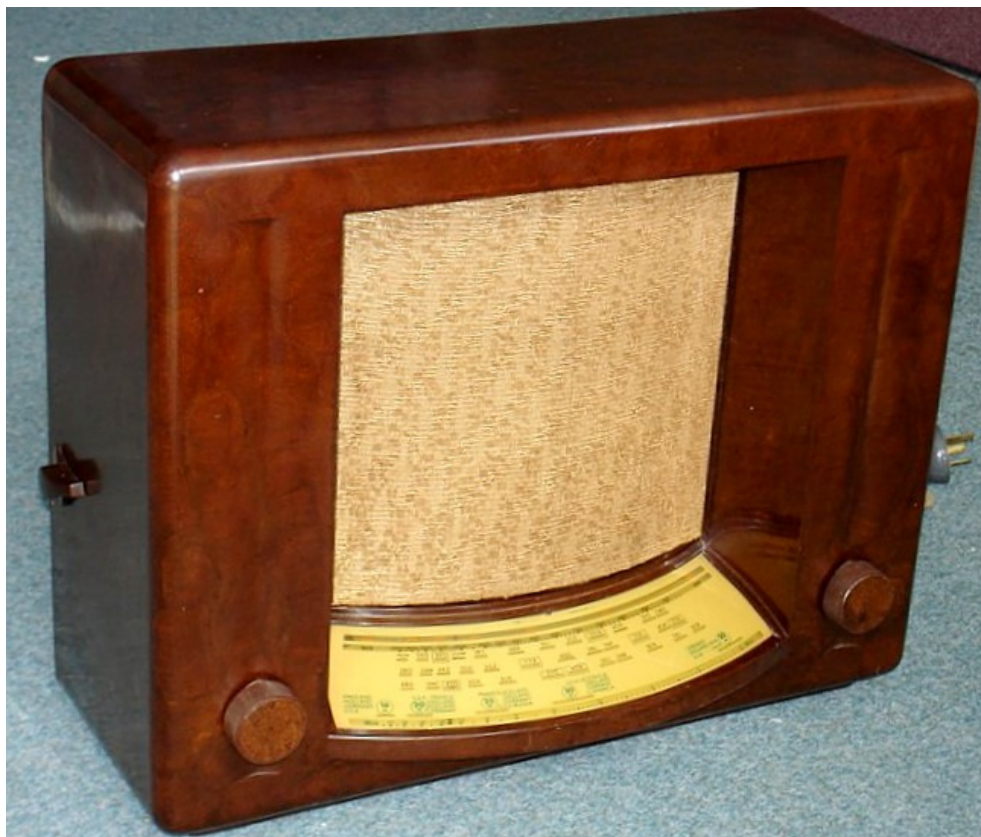
Above: Finished product.

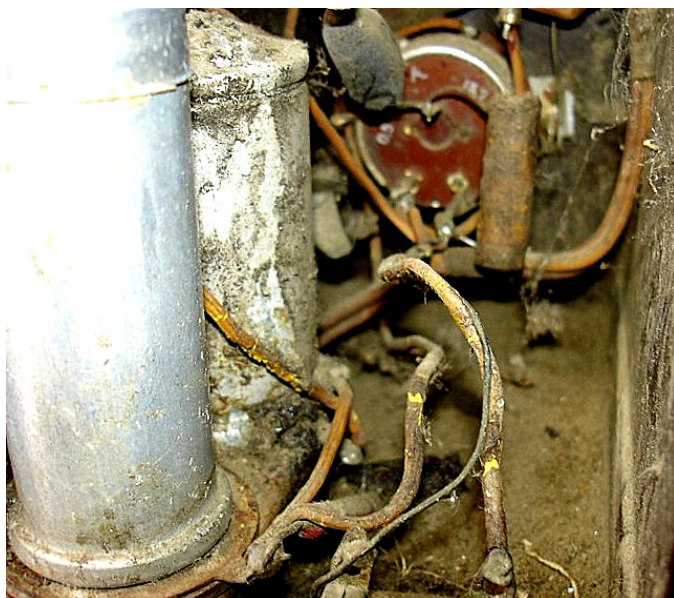
Left: some original conditions.

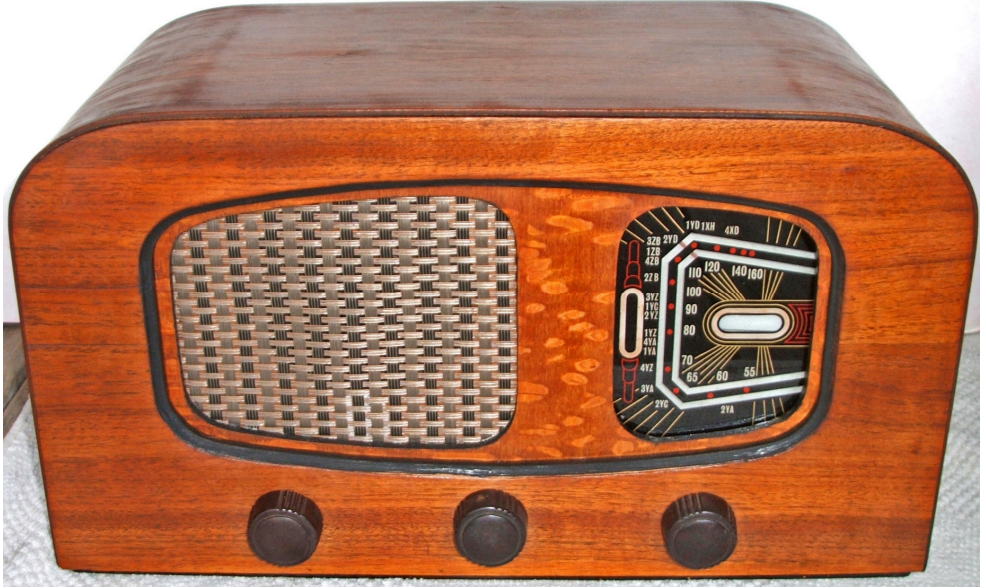
This is not a description of a restoration project in rebuilding a vintage radio to its original specifications, but rather about using modern technology to upgrade an old radio receiver to a higher standard. The objective was to take an old valve radio and customise it using current technology and engineering standards to improve the safety, efficiency and reliability of the resulting “modernised” radio.

I chose a small, mains-powered, circa 1940's receiver, using octal valves. This radio, brand-named “Westco” was apparently manufactured in New Zealand. It was not rare and neither valuable nor important in any way that it should be kept authentic.

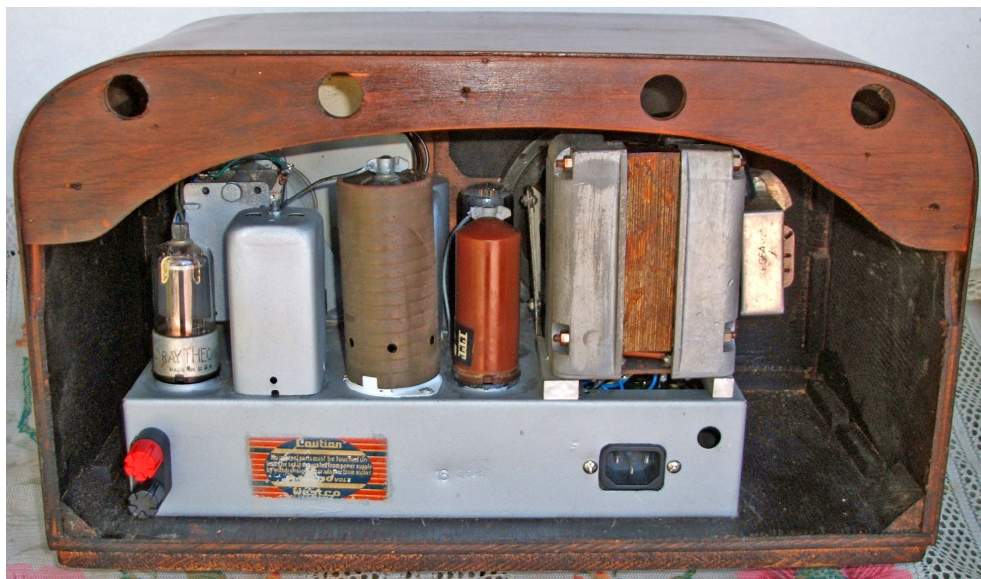
Finished refurbishment above and below

All the original capacitors and resistors were replaced with superior modern types of the correct value. For resistors I used high-stability metal film (1%) or carbon film (5%) types. For high-voltage capacitors I generally used polyester or polypropylene types and for low-voltages, mylar greencaps. For tuned RF circuits I used high stability polystyrene or npo-ceramic
