NZVRS BULLETIN

Vol 34 No 1

February 2013

Restoration of a Philco Model 18 Cathedral Radio

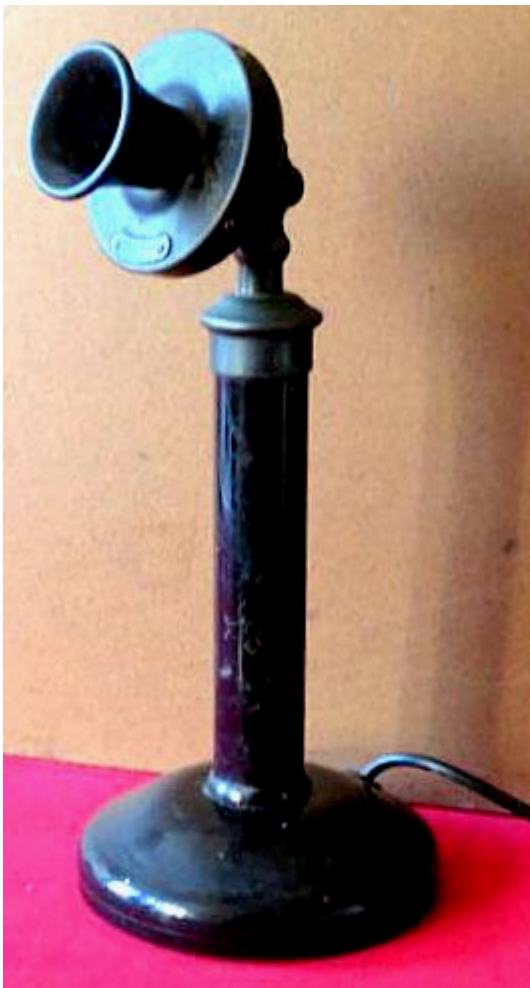
This (pix on right) will be the very top shelf microphone in the Coastwatchers hut. The plate on it reads: 250EW Western Electric Made in USA Pat in USA Jan 4 1913. All the best, Murray Dick

I do not know what the equipment rack is, but it appears to be a transmitter at the top, then a speaker, a receiver in the middle, and a power supply at the bottom.

In the No3 Camp photograph, there is a Teleradio 3A receiver at the bottom (square dial, many knobs) and a Teleradio 3A transmitter above it, with a microphone hanging down. It is a telephone handset with the earpiece cut off.

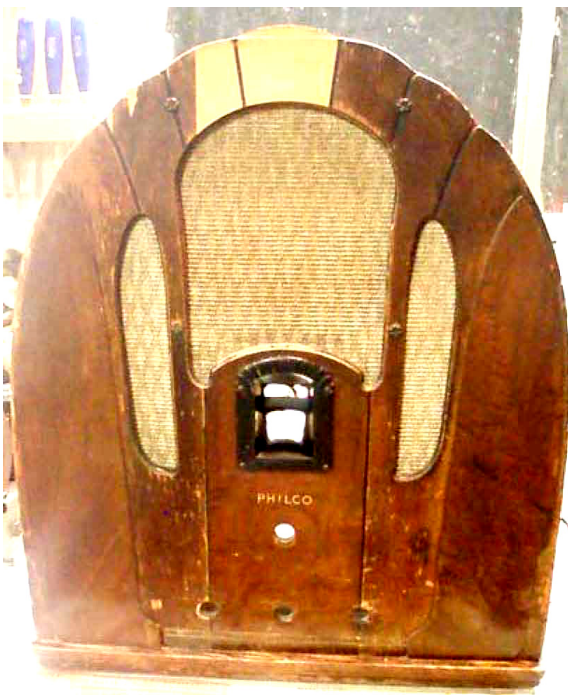
First up was to carefully document and strip the chassis. Once again Nostalgia Air provided valuable circuitry, layout and alignment information. From the photo below it is evident that over the years faulty components, mainly the bakelite block capacitors and power supply electrolytics, had been replaced with individual units. The underside of the chassis was a mess. Fortunately all the original cans and blocks were still present. There are two wire wound resistors, one in the bias chain and the other in the main HT line, both of which were open circuit. The mixer and oscillator coils both had open circuit primaries, the shadow meter coil was open circuit and most of the carbon resistors were wildly different from their stated values. There wasn't one capacitor in the whole set that was able to be reused! All the transformers, the power supply filter choke, the IF and aerial coils and the speaker magnet coil were continuous and tested well for insulation with my 500V megger. Later at initial switch-on, the

primary of the audio driver transformer went open circuit after about 2 minutes of operation. This necessitated a complete rewind because the primary winding was the first on the former. – of course!

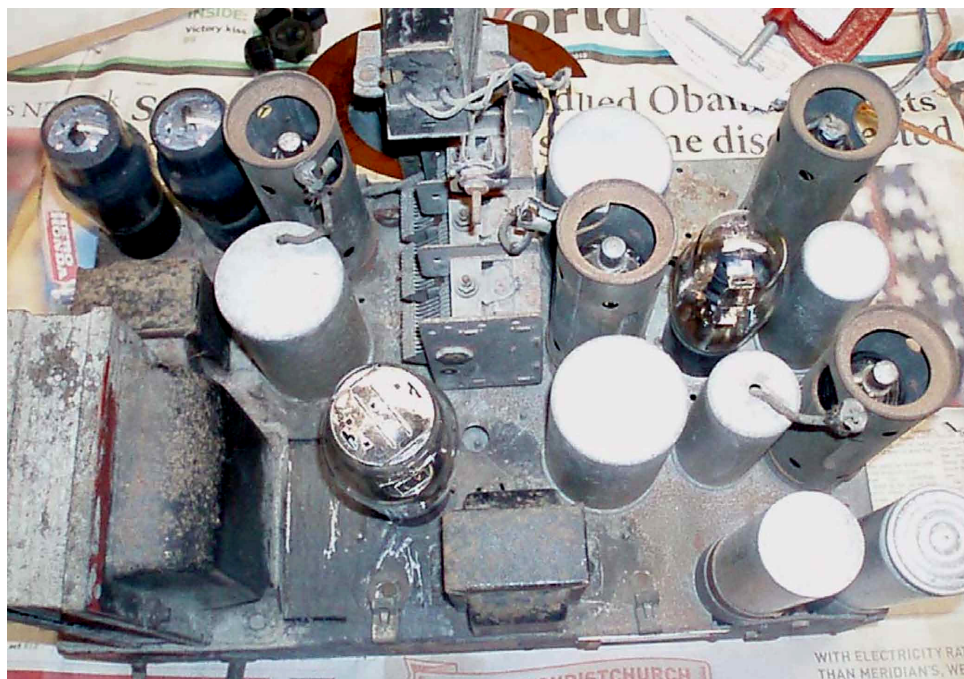
On return of the brand new looking chassis, re-assembly began with the installation of the valve sockets, cans, transformers and tuning condenser on new rubber mounts. Then, many hours of pouring over the circuit, photos and notes, disappeared before the chassis was again complete. Yes, the waxed paper capacitor connected to the volume control is the only non-

block capacitor in the whole set. I was able to rewind the bias wire-wound resistor but not the HT one which has been replaced with a ceramic wire wound resistor although the original is still in place. The speaker was reassembled and this proved to be a time-consuming, precise job. After the fitting of a new power cord, with an earth this time, it was switch-on time.

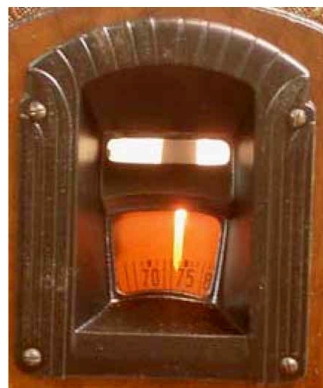
Repair of the dial escutcheon was achieved with the help of some epoxy resin. After this had set it was filed into shape and sprayed black. Nearly eighty years had taken their toll on the celluloid dial which was coated in dirt and almost unreadable. The dirt was removed using Brasso and a surprising amount of elbow grease. Luck was on my side here as the dial markings are on the underside and the dirt was on the top side. A new replica ARTS&P label and the cleaned

and polished makers label, which was in particularly good order, were reattached to the chassis to complete this part of the job.

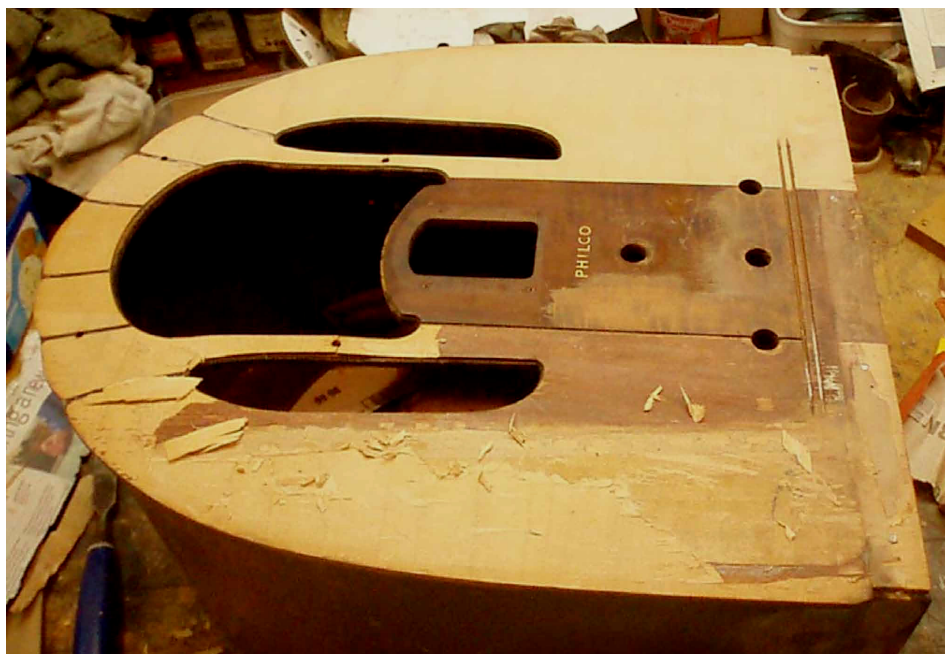
Cabinet repair in progress

The centre piece of veneer around the dial escutcheon was of good quality and it was in good order, but it was very apparent early on that the only way to repair the larger part of the front was to replace the veneer. Before removing the old veneer a rubbing of the lined pattern was taken so that it could be reproduced in the new veneer. Also the removal of the two pieces of thick, high quality veneer, one to each side, and the moulding around the bottom was needed. It was a painstaking job to remove these pieces as, in contrast to the rest of the gluing on the cabinet, they were stuck fast. However patience prevailed and in time I was rewarded. The rest of the front veneer came off very easily. The curved top of the case fits, and is glued into, a slot routed into the back of the front, but over time, the back two layers of ply had fallen off and there was only one small piece remaining. It was a tricky job to set up the router to remake the missing pieces so that they fitted snugly around the case. Once again patience prevailed and the reward was granted. During this time, at the end of each session the painstaking job of forcing glue into the delaminated ply and cramping each little piece with small G cramps continued. There were numerous places where the glue between the ply laminates had failed and the case had become quite unstable. However this came right slowly and the cabinet became rigid again.

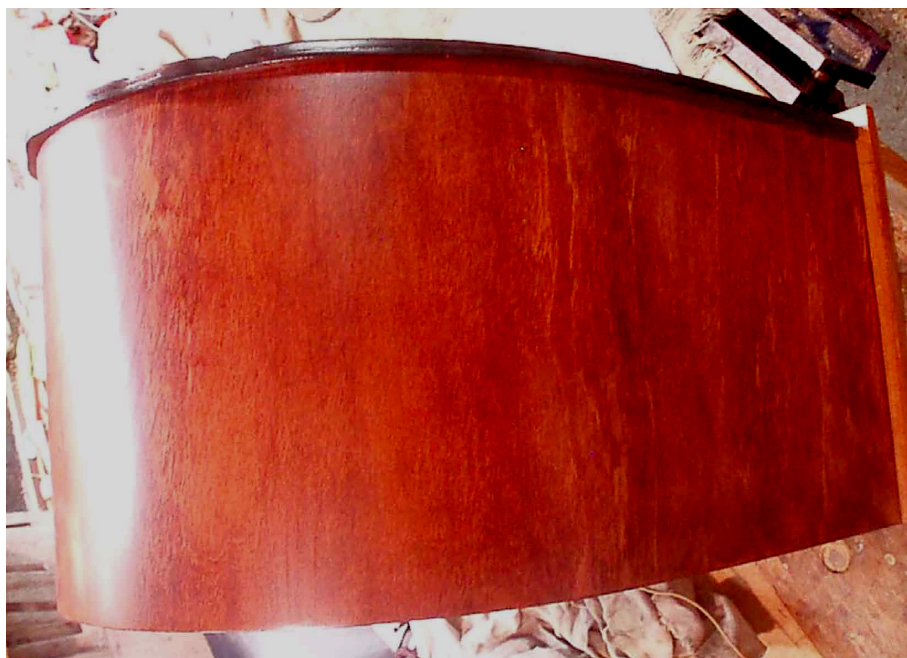
Above: Cabinet recoloured

That job complete, I stained the new veneer and moulding with a water based, rub-on stain. The rest of the cabinet still had some colour so I lightly stained it with a diluted stain until everything matched. The timber of the two pieces that had been removed from the front and the central part of the front are of dark, beautifully grained timber which did not need any staining. It was time now to fit the new moulding and refit the two pieces of veneer to the front. The cabinet was now complete and certainly looked a lot better than when I had received it! As I am not very proficient with a spray gun, I finished the whole cabinet using satin polyurethane thinned 50% with turps, put on with a brush. There is a total of eight coats with a sand using 00 wet & dry, dry, between each coat. The shine slowly builds and the finish is smooth and rich. After the second polyurethane coat and with a fine artist's brush, I painted all the necessary edges and lines with black paint. The remaining coats of polyurethane brought the paint to the same finish as the rest of the cabinet. Finally a replacement transfer was floated onto the cabinet.

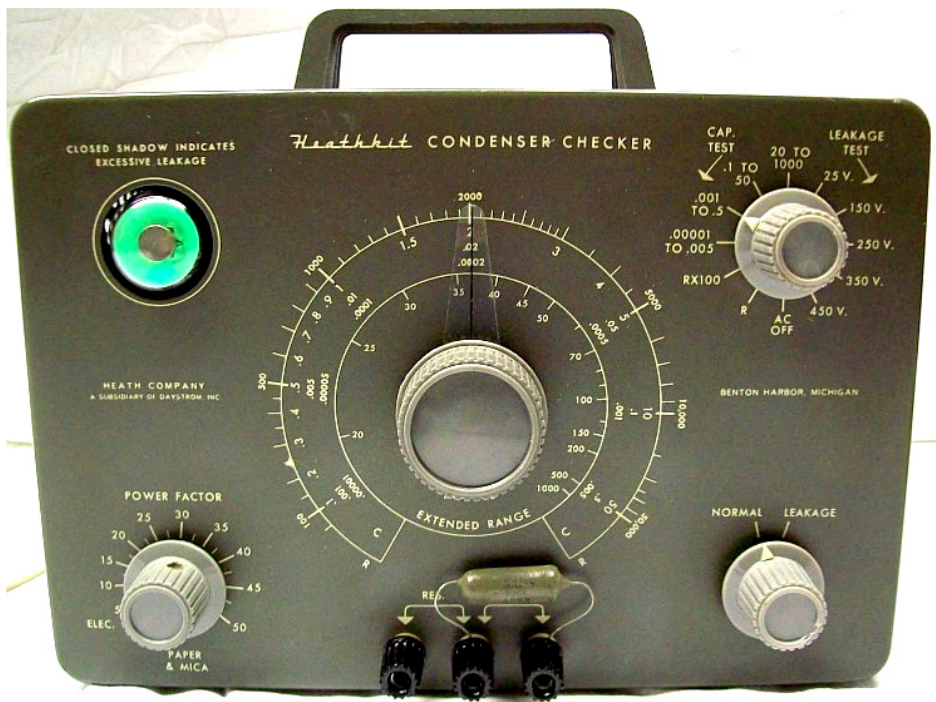
A useful item of test equipment for servicing vintage radios is the resistance - capacitance bridge which uses a magic eye to indicate the balance condition. Typical bridges of the 1950's and 60's were the Heathkit, Paco, and the Japanese TMK. They all used the principle of the

Wheatstone bridge which was energised by about 50 volts AC which was applied to opposite corners of the bridge while the detector (magic eye) was connected across the other two corners. When the bridge is balanced, there is no grid voltage on the detector and the shadow is wide open. When looking at the circuit it is not at all obvious how the instrument works, and when you see an unintelligible circuit my advice is "when in doubt, redraw" to show the separate functions such as measuring R and C and testing for leakage.

The redrawn circuit may be unconventional in that the negative voltage of 450 volts is at the top of the circuit, but this has been chosen so that a negative voltage can be easily seen between grid and cathode of the magic eye. We notice that two resistors are shorted out when testing electrolytics because their higher leakage produces sufficient grid voltage across the 1 K resistor. The leakage test control has a return spring to automatically disconnect the capacitor because 450 volts could be bad for the operator. When the leakage switch is turned clockwise (against the spring) the shadow closes momentarily then opens quickly but as the shadow opens wider the opening becomes slower. The voltage across the grid resistor (1K or 471K) is proportional to the charging current of the capacitor and the opening of the shadow is a visual indication of the exponential charging current as shown by the waveforms in the top corner. The charging current decays exponentially and the shadow opens at a slower rate as the current drops to zero.

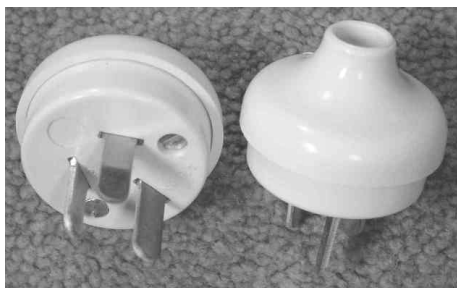
Power plugs (Tilley white plastic type with unprotected brass pins as pictured above) available at 50 cents each plus \$4 post and package per set of 4 (ie \$6 for set of 4, posted to an NZ address).
