# NZVRS BULLETIN

Vol 37 No 2&3 double issue

**Competition Winner AGM 2016**  
**Peter Lankshear's Simple Set**

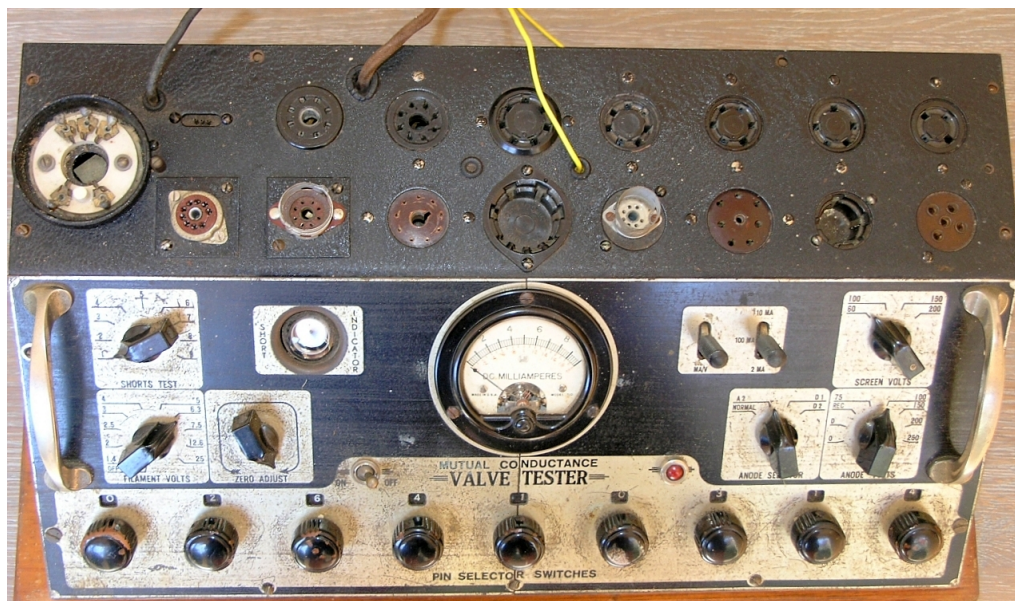
Top; RDL Valve tester, internals middle and the AVO book 9 digit selector settings

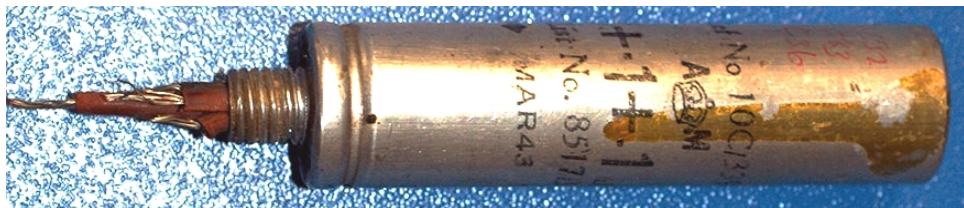
Above the R1155 3 capacitor assembly.

The first step is to drill out the old leads and about 50mm of the internal condensers using a 5mm drill. The new insulation material is a length of drinking straw about 5mm in diameter into which will be inserted the new capacitor assembly.

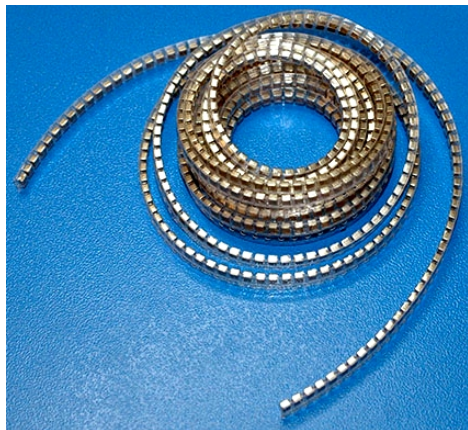
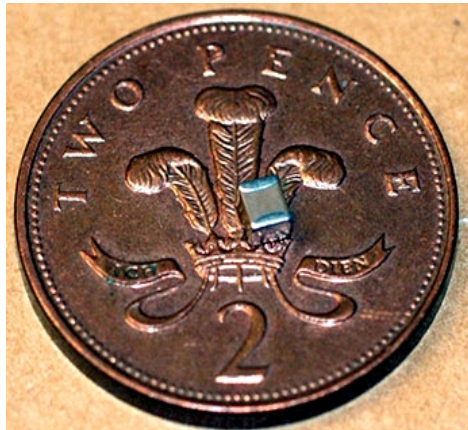
Below the raw materials: A roll of 0.1uF x 500v surface mount capacitors left and with one shown on a 25mm diameter 2p piece on right.

In the R1155 example, I'm going to restore a 3 x 0.1uF condenser (which is about 85mm long and 18mm diameter, rated at something like 350V and made in 1943) using three chip capacitors each with a "1210" type case whose maximum dimensions are 3.3mm x 2.6mm x 2.1mm.

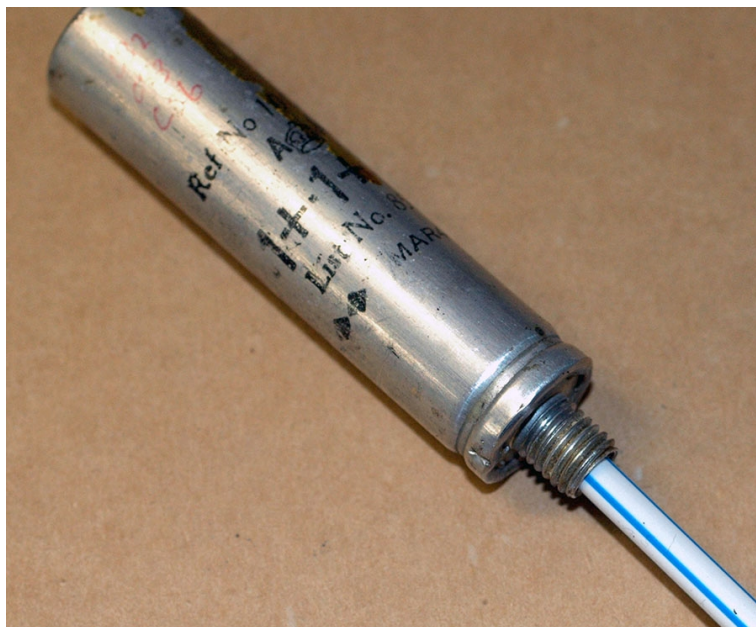
Because the old condenser has a common ground wire to the three 0.1uF sections I've used a new black wire connected as shown above. To solder the wire some sort of clamp will make things easier otherwise the lightweight capacitor chips will just stick to your soldering iron.

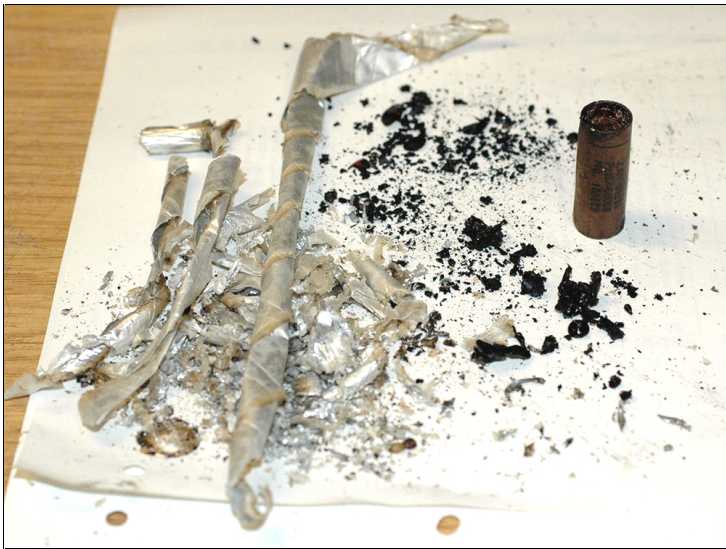
**Above the removed foil and paper contents of the old capacitor**

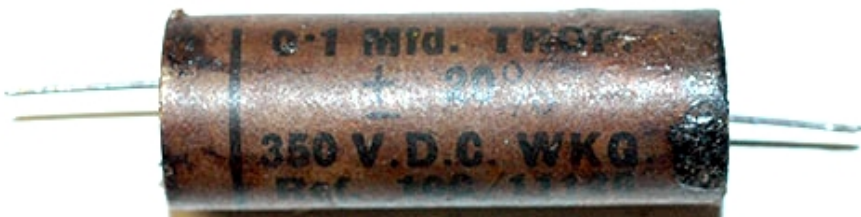
**Below the completed item, the ends sealed with cardboard disks and pitch.**

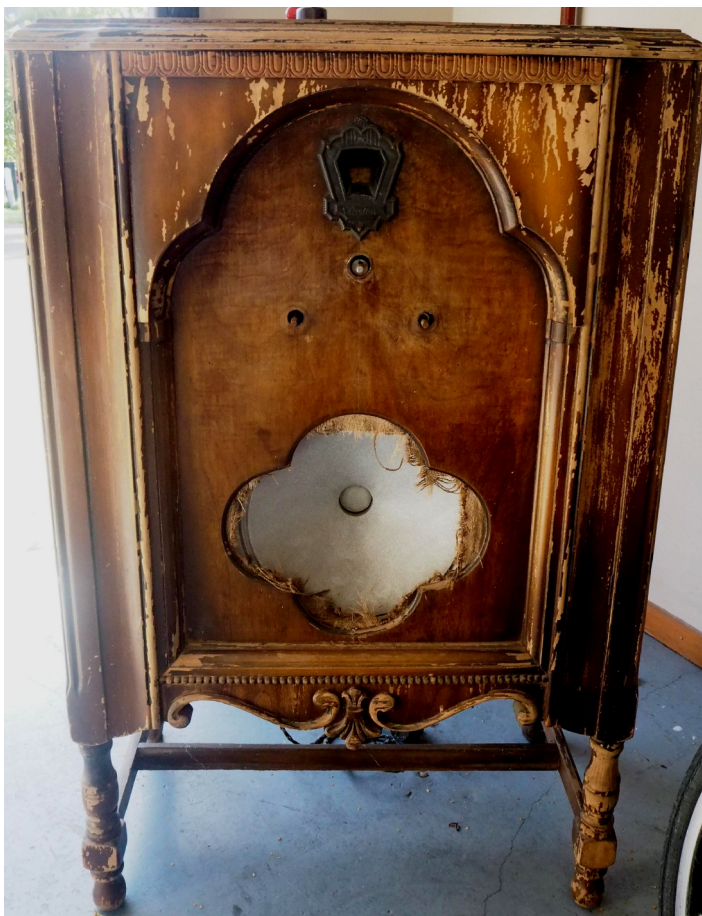
Much of the cabinet's veneer was lifting or lifted - fortunately none was missing. Two legs were damaged, the varnish was crumbling, the knobs and grille cloth were missing and the chasses were badly corroded. It was very sad indeed. Miraculously, the speaker cone was pristine.

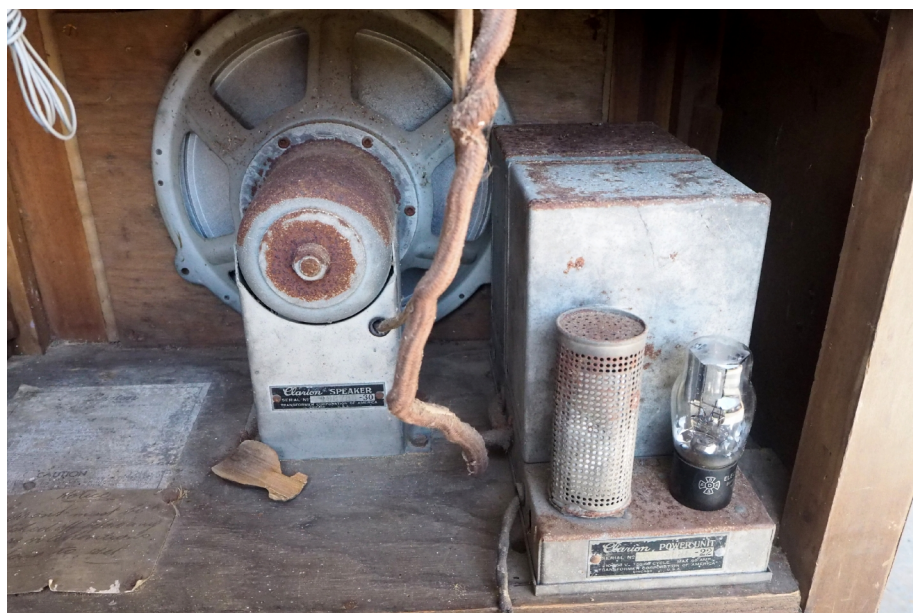
On the power supply chassis are two large & heavy cans. One contains the power transformer, the other, two filter chokes, four electrolytic filter capacitors and the output stage cathode bypass capacitor. The power transformer tested good and it was at this point that I discovered that the voltage regulator, (which is simply a nichrome resistor wound on a mica former enclosed in a perforated metal container and connected in series with the primary,) drops the primary voltage to 187 volts. It is actually a very satisfactory heater! In the other can both chokes were open circuit and the four filter caps were very leaky. As both cans needed to be replated, I had to remove their contents which were encapsulated in pitch. The curing oven at work provided the perfect solution.

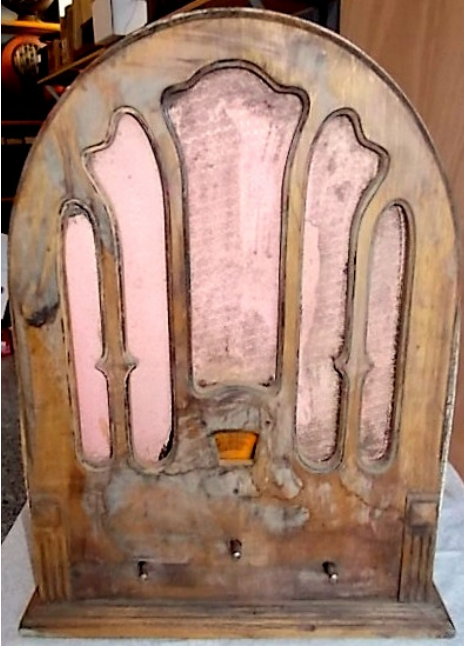
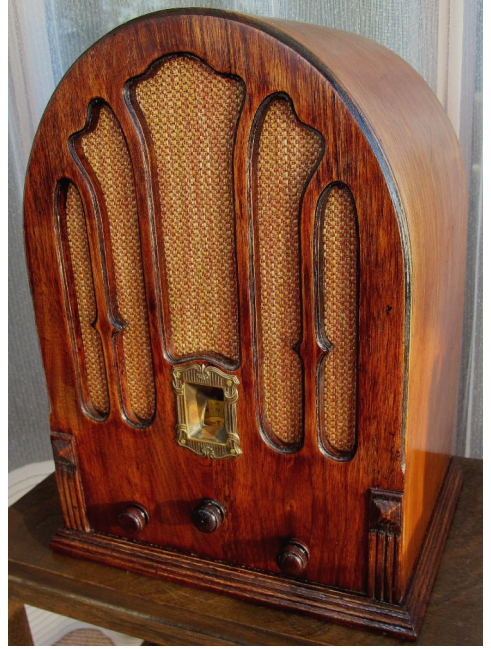
**Above: Before and after**

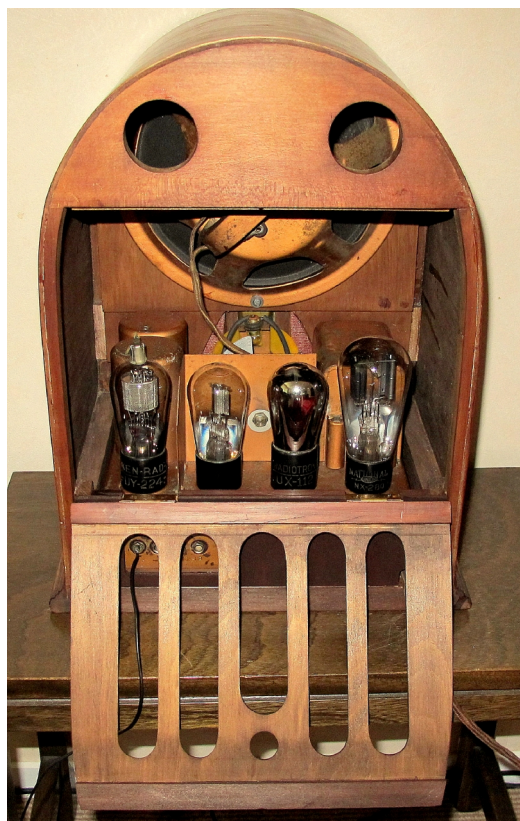
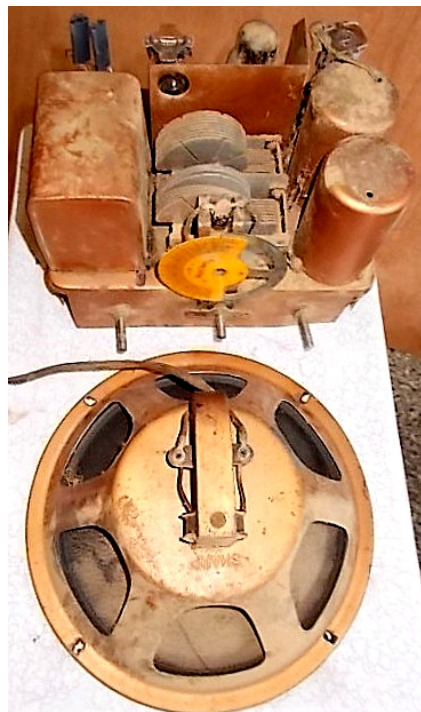
**Above Repaired Set Rear View, Others are before**

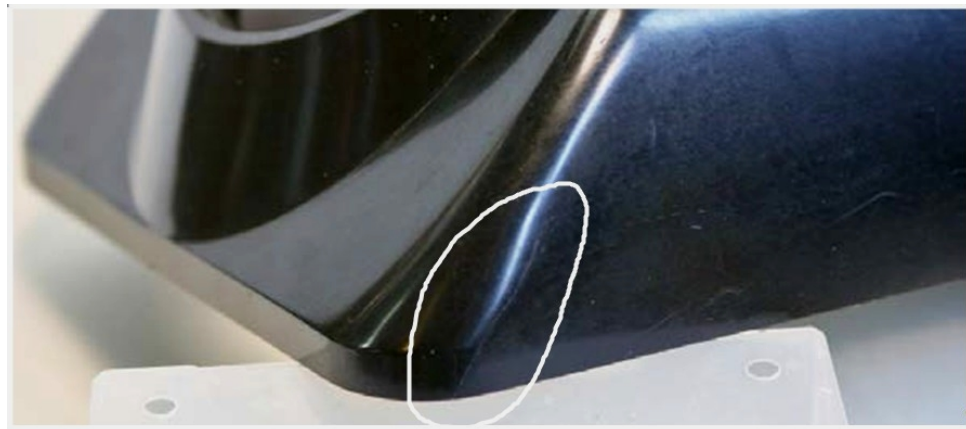
In this case I am repairing the front corner of a Heemaf 1955 telephone. A crack in this position is a common occurrence. It is at a dangerous position, because here at the business end of the telephone there is a risk of cracking further, so a repair is needed.

An often irritating problem is a small crack in a bakelite telephone (or other bakelite object). Bakelite is, after all, brittle and this kind of damage can easily occur. In this article I will show how to do a relatively easy repair. It does however take some practice, so please try it out on a test subject first. Please do mind that it works best on black (really black) bakelite. It works on other plastics too, although other plastics may better be repaired with another type of glue. The blacker the material, the less visible the repair will be. We are using super glue, as it is translucent when dry it will take up the colour of the surrounding material. There is no need to colour the glue before applying.

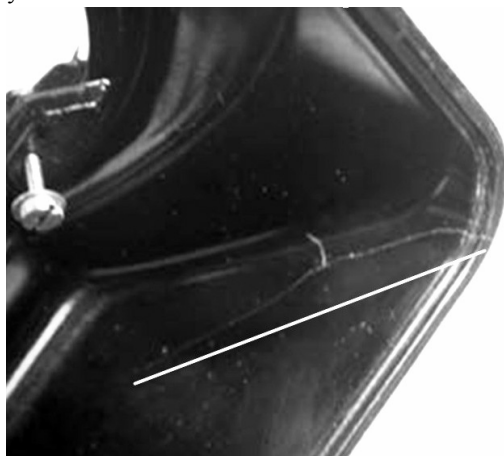
**Right: Inside view with white line indicating the length of the crack.**

In this example the telephone in question was going to be used on a daily basis and not just a static display. Leaving the crack as it was would risk further cracking and possible breaking off. Also of note was that the crack was much bigger on the inside than visible on the outside.

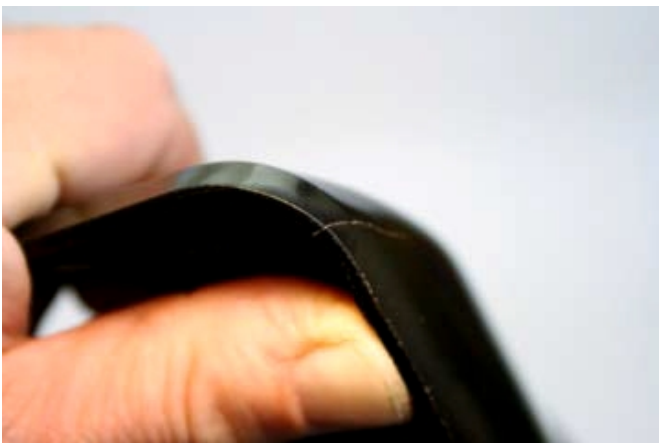
First, wash the object and make sure the crack is clean and there is no dirt around it. Also make sure there is no dirt in the crack itself. Brush along the crack with a stiff brush and soapy water. Make sure it is dry for the next phase.

We are going to put glue in the crack later, so it is important to see if the crack closes properly. Both sides of the crack need to be as flush as possible. When you go across it with your fingernail, you must not feel a ridge. Please mind to go across it both ways! Do you feel a ridge? Make sure the crack is clean and nothing is stuck in it. Also try pressing it closed and see if it fits better that way. If you cannot get it to close properly, you may want to reconsider repairing it.

When we put on the glue later on in the process, we are going to wiggle the edges of the crack. This moving the edges of the crack will cause the glue to permeate fully through the crack.

That is also the reason why we need slow setting super glue. Otherwise it will harden before the glue has fully penetrated the whole crack. Do mind that you do not put too much force on the crack, otherwise it may crack even further or you may even break off a piece of bakelite. You only have to wiggle it a little bit.

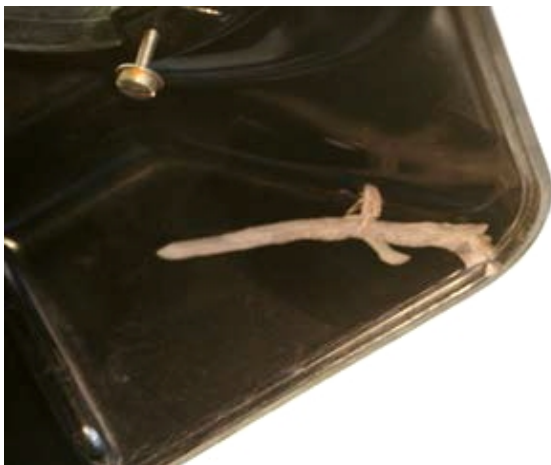
### **Put it to the grind stone**

Sometimes I grind out the crack on the inside of the piece I am repairing. There are a number of reasons why this may be advisable to do so. Firstly, we are going to put the glue on the inside of the housing, squeezing a small line over the crack. Grinding it out makes the gluing a lot easier. The glue can be put in the ground out trench easily.

In this case the crack was longer on the inside than on the outside. I wanted to make sure I reached the very end of the crack with the glue, making sure the whole crack was glued. The crack in this case is in an area that is exposed and we do not

want the crack to reappear. Also the position of this crack made it possible to grind it out.

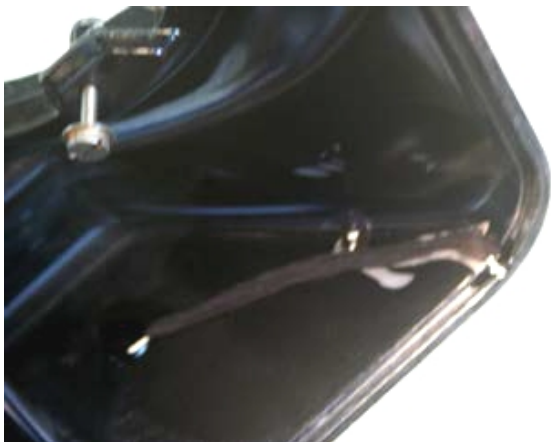
### **Glue and wiggle and glue again**

So, now we are ready to glue. We are going to start on the inside of the housing. In this case I have put a steady line of glue along the ground out trench. If you have not ground out the crack, just put a nice bead of glue over the crack itself.

After applying the glue, start wiggling the edges of the crack. By the motion of each side of the crack, the glue will permeate through the whole crack. After a while the glue will start to appear on the other side, in this case the outside of the telephone. Please do not stop at the appearance of the first small drop. Continue wiggling until all along the outside of the crack, drops of glue start to appear. You may want to apply some more glue on the inside and start wiggling again.

When the first glue is well distributed, leave to set. Make sure the crack is closed properly and the 2 sides are flush. This is a critical moment. The more flush the two sides are, the less visible the crack

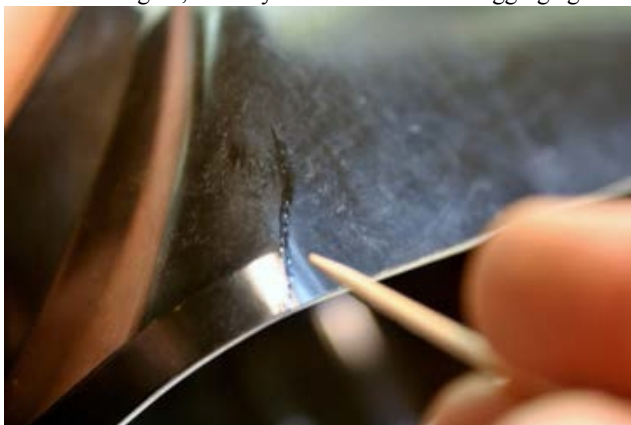
will be when finished. Hold the crack in place until the glue has set. You may speed up the setting process by breathing on the wet glue, like you would when fogging glass. Cyanoacrylate (superglue) sets quicker, when it comes into contact with moisture.

When the glue is set, take a toothpick and put a line of glue over the crack on the outside of the housing along the whole crack. You may want to repeat that 1 or 2 times. The glue will decrease in volume when setting. This forms a slight trench along the crack. It needs to be completely filled before we can start sanding.

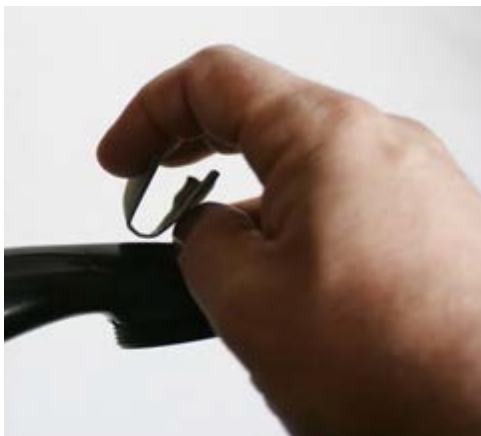
### **Sand, sand, sand**

Now we are going to carefully sand away the excess glue with 800 grit sandpaper carefully bent into a U-shape. With this bent piece of sandpaper I take great care to sand just over the glued part and try to avoid sanding the surrounding area as much as possible. Sand it down until all the excess glue has gone and the surface is totally smooth. Then carefully sand it again with finer and finer sandpaper.

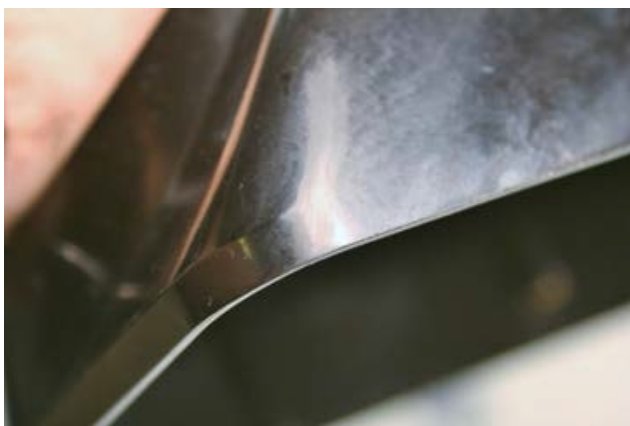
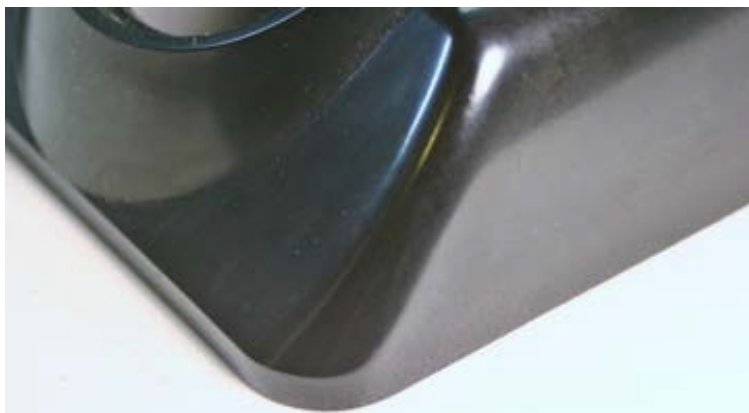
### **Polish, polish, polish**

First I polish the sanded area with Autosol car scratch remover a couple of times, using a felt polishing wheel on my Dremel tool. Afterwards I polish it by hand with an agent called Displex. {Displex is a compound for removing scratches from telephone touch screens. It works really well on plastics too.}

### Show it off to your friends

If all goes well, the crack will be invisible. And you end up with this result, see last picture. Please mind that when the bakelite has faded a bit, the crack will show up black. But in this case I am very happy with the result.

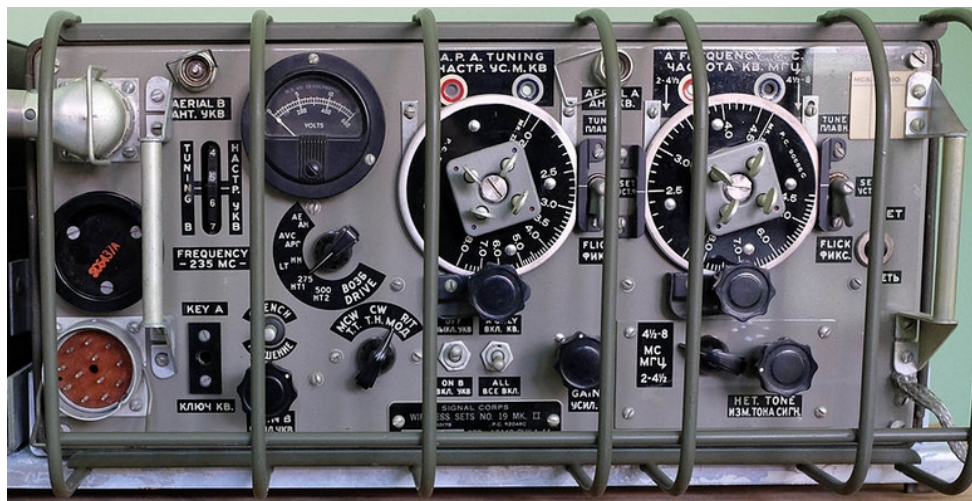
## Block Diagram of the No. 19 Set Receiver

The BFO is within a few kHz of 465kHz and when subtracted from the local oscillator frequency the difference is within a few kHz of the received frequency and within the pass-band of a similar receiver.

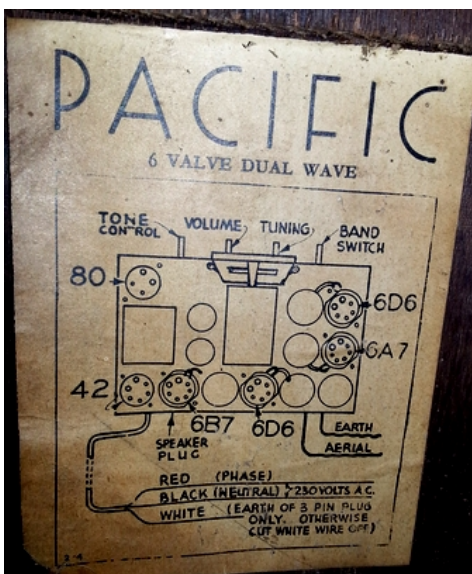
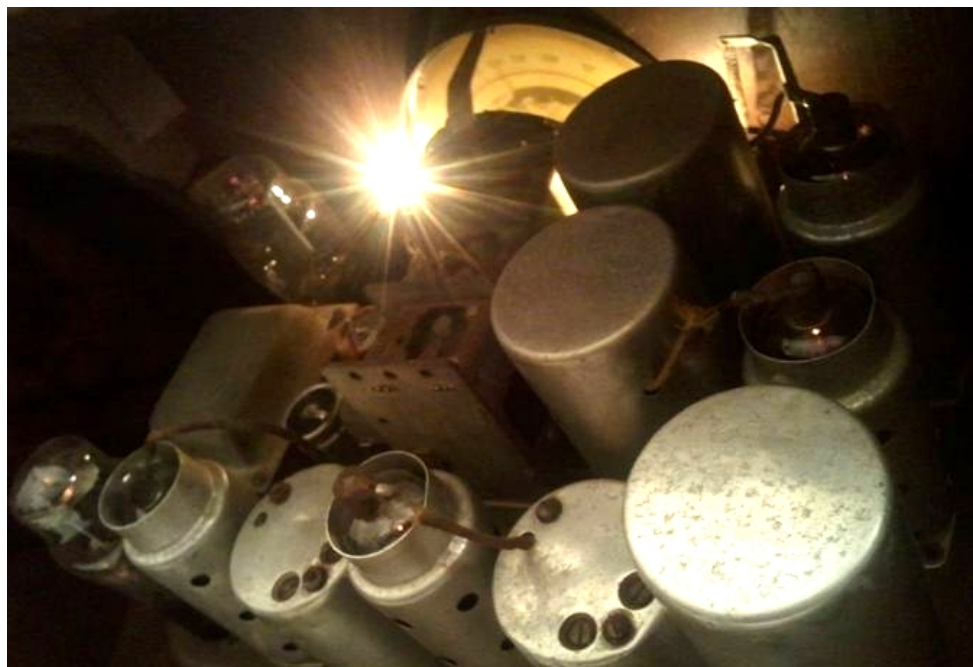
**Above & below: Elite chassis – 6 valves**

From what I can tell it was made by RCNZ for Pacific Radio and the chassis was used in both this cabinet, the awesome 'Elite', shown opposite and possibly the other standard-design console shown below (the owner of that one has a 7-valve chassis which is quite different).

I want to restore mine, but the chassis has been changed to the wrong one, and mangled, and retrofitted with late-40's circuitry, which means I need to scratch build something. The RCNZ model 18 chassis is similar (same valve lineup, also dual-wave, but subtly different layout of coils, valves and controls - although the controls have the same spacing) so I am using a parts model 18 chassis as a base, but I don't have the schematic for the Pacific 6-valve and the library doesn't either. What I'm hoping is that someone out there does - and/or maybe someone out there has the Pacific 6-valve chassis in one of their radios that I could take some detailed photos of and reverse engineer something to suit my cabinet.

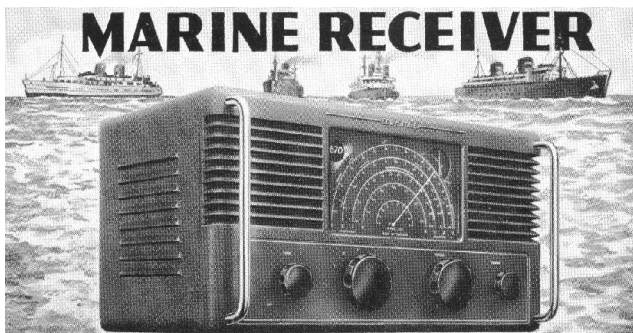
These sets were designed to operate from 230V or 110V AC or DC as found on ships. The basic circuitry (valve heaters and HT supply) were designed to operate on 110 volts, and when used on 230 volts the extra 120 volts was dropped by a large wirewound resistor (about 12cm long and 3cm wide) mounted inside the case near the speaker. The heaters of

the U-series Rimlock valves were wired in series parallel and fed through a thermistor so that the voltages added up to 110 volts. The thermistor protected the valve heaters from the initial current surge, although it delayed considerably the heating up of the valves. A selenium rectifier was mounted on the chassis and supplied the HT voltage by a half-wave circuit. One side of the mains (preferably the neutral!) was connected to the internal chassis, but if the mains plug / lead connection was reversed then the internal chassis would become live. For safety, the internal chassis had to be insulated from the outer metal case and front panel. The metal case should be earthed unless the set is supplied from an isolating transformer.

When purchased as a restoration project, a few components had been replaced but the set was not working. Other resistors and capacitors were replaced, the output transformer was OK, but the main dropping resistor (500 $\Omega$  @ 50W) was open circuited, and a suitable replacement was fitted. Selenium rectifiers generally show their age by developing a high forward resistance, and less HT voltage, so it was replaced by a silicon diode with 22 $\Omega$  in series. The filter choke was not original so a more suitable one was fitted. The mains polarity was confirmed (neutral to chassis), and when tested it worked on broadcast but clearly needed alignment. After a few minutes it was found that the large dropping resistor generated a lot of heat which would have heated up the outer case. What was more important was the condition of the insulation between the internal chassis and the outer metal case and the diecast front panel. There are Paxolin strips separating the internal chassis from the outer metal straps that wrap around the chassis, and there are Paxolin tubes and washers to insulate the front panel from the coil box which was part of the internal chassis. An initial test with an ohmmeter showed good insulation, but a megger test with a higher voltage showed that there was leakage of a few thousand ohms, which was unacceptable. It was not a practical proposition to remove the faceplate and the screws holding the front panel to the chassis and replace the Paxolin tubing and washers, so it was decided to remove the large voltage dropping resistor and run the set from a 110 volt isolating transformer. The set worked on the lower bands, but an external transformer is a nuisance. There was still the inconvenience of a long warm up time because of the thermistor (carbon rod type) in the series heater string.

which made access to other components somewhat difficult, so two small tag strips were fitted on the chassis for the HT wiring. The thermistor was no longer required, and the valves heated up more quickly. In the course of rewiring the heaters from series to parallel, about two metres of surplus heater wiring was removed. The push-pull UL41's were replaced by two EL42's as used in car radios and they worked well and drew less current than push-pull EL41's. The HT voltage was about 230 volts and it brought the top short wave band back to life. At the same time R12 and R13 in the oscillator circuits of V2 were deleted and R14 was reduced from 560 to 56 ohms. The audio driver valves which were originally UAF42's were replaced by EAF42's and both types gave more audio gain than needed. If two EBC41's were used, with the diode units tied together, there should still be sufficient audio gain, and the circuit would be simplified with the removal of two screen resistors and two bypass capacitors. In this circuit the grid voltage for the second driver is obtained by tapping off the output voltage of the first driver, and with the lower gain of triodes the value of R25 would have to be increased to tap off a larger proportion of the voltage. The model 670 has a push-pull output (originally UL41's) driven by the push-pull driver stage of UAF42's. The circuit is sometimes called a paraphase circuit, and the audio output of the first driver is tapped off to feed the grid of the second driver with the correct voltage level (which equals the grid voltage of the first driver). For example, if one volt of signal at the first driver produces an output of 20 volts, then 1/20th of this output is tapped off to feed the grid of the second driver. This gives one volt of AC signal for the second driver so that its output will also be 20 volts (with the required phase relationship) so that the output valves will give a balanced output.
