BULLETIN No. 111.

TECHNICAL DESCRIPTION AND ADJUSTMENT PROCEDURE

"CROMWELL" 7-VALVE ALL WAVE RECEIVER. 1936

COLLIER & BEALE LTD.

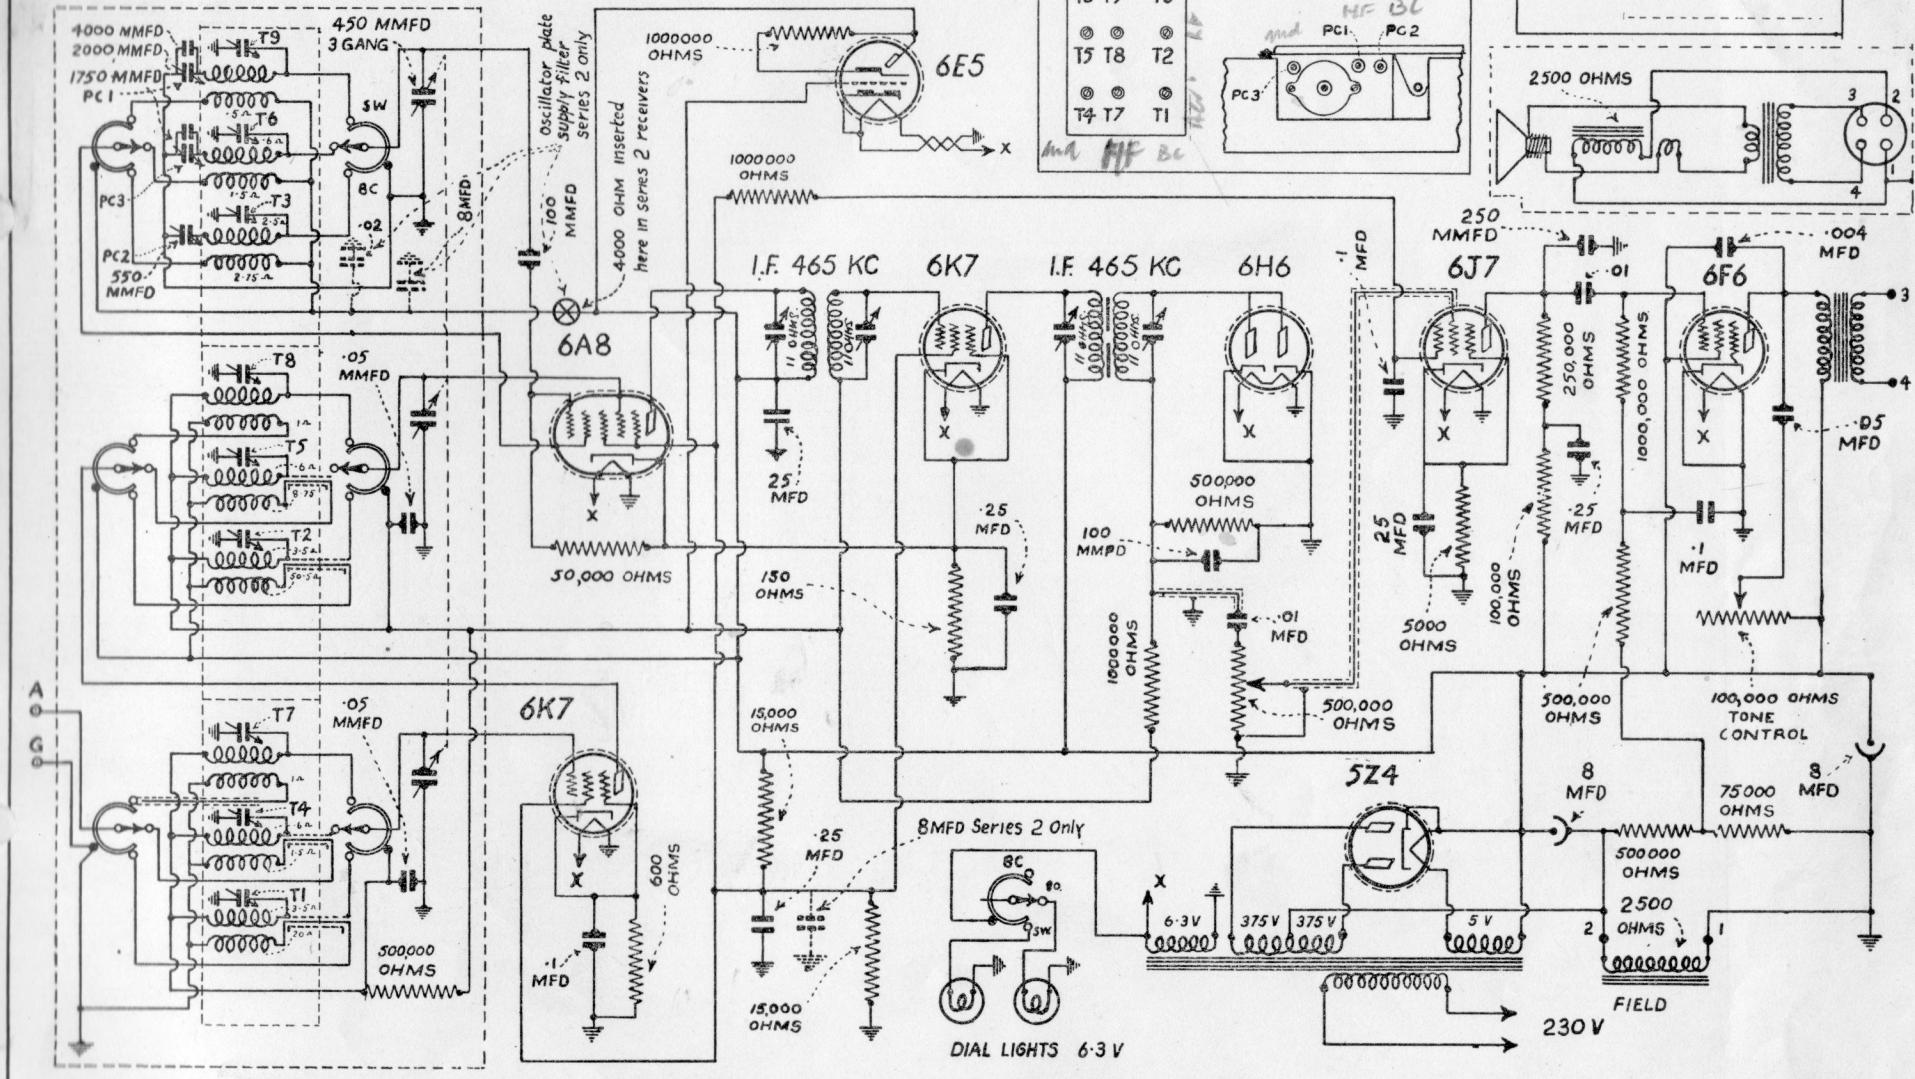
CROMWELL 7AW RECEIVER

ALIGNMENT PROCEDURE; Sufficient detail has been shown on the schematic diagram to permit the intelligent adjustment of this Receiver, if and when found necessary. The alignment procedure should be carried along general lines. The method adopted at the Factory may be of

As is usual, T. 3., or the oscillator trimmer, decides the pointer indication. A test frequency of 1500 or 1600 Kilocycles should be used. After correct pointer setting, T. 1 and T.2 should be adjusted for maximum response. The Receiver should now be turned to 600 Kilocycles and, without using a test signal but still having an antennae or "Dummy" connected, proceed to adjust the broadcast padding condenser - P. C. 2.

The correct setting of this Padding Condenser can quite readily be obtained by the maximum level of the hiss or Receiver noise. If this adjustment has necessitated a large change, it will be necessary to recheck the oscillator trimmer - T.3. The same procedure should be adopted with the intermediate short wave band. In this case, the oscillator trimmer is T.6; the padding condenser P. C. 3. Test frequencies of 6.5 and 2.5 megacycles should be used. In the high frequency short wave band, the general procedure, as used in alignment of the broadcast frequency range, should be adopted. The oscillator trimmer, in this case, is T.9; the padding condenser P.C.1.
